20 Pump Fire Preliminary Report

New Providence Wharf
1 Fairmont Avenue
London E14 9PL
Borough of Tower Hamlets

Date of Incident: 7th May 2021
Date of report: 25th May 2021

Fire Investigation Team Report

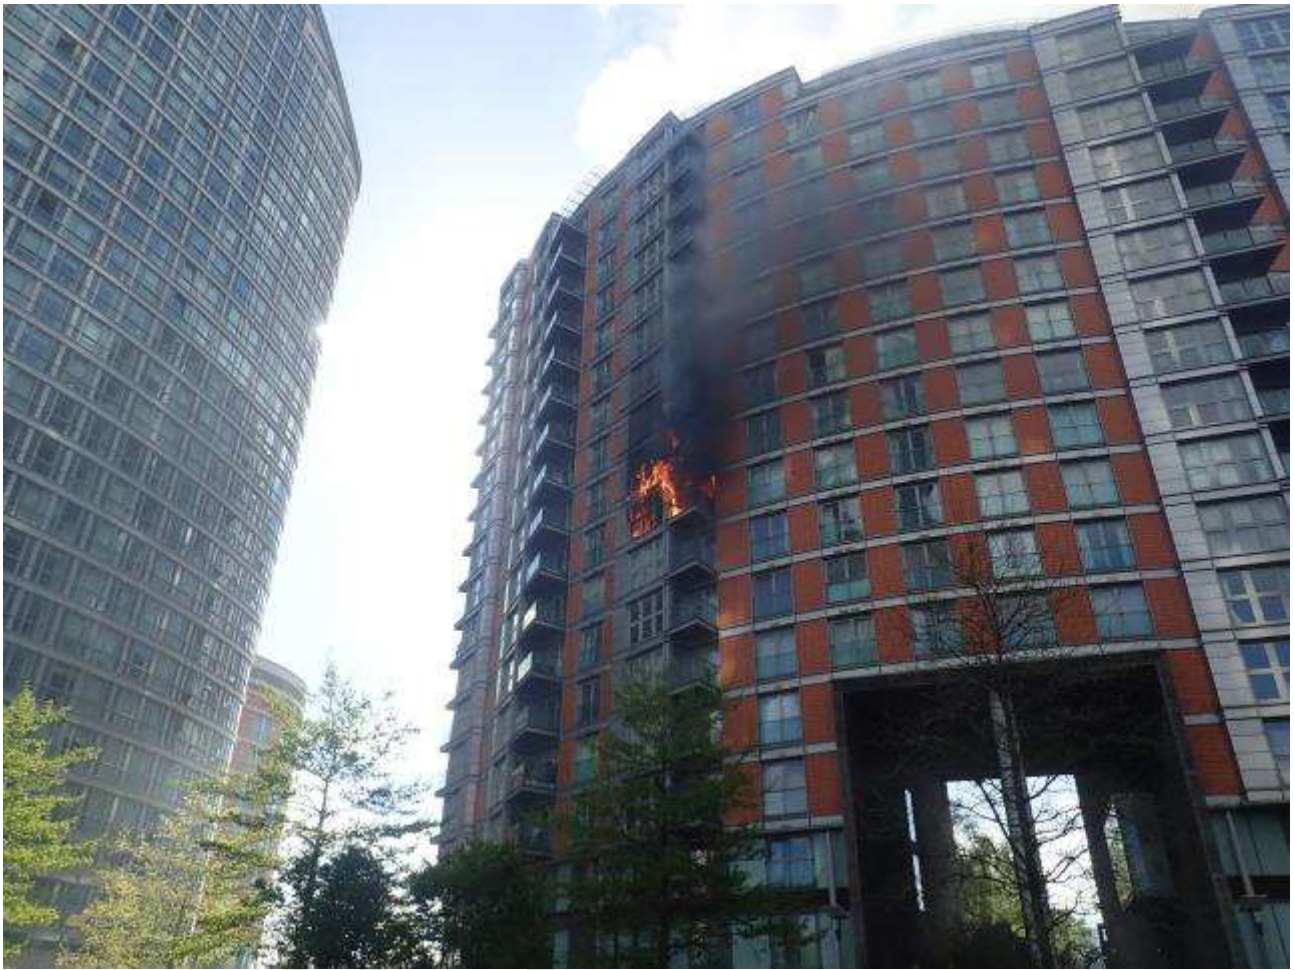
Image showing the fire in progress on the North face of NPW

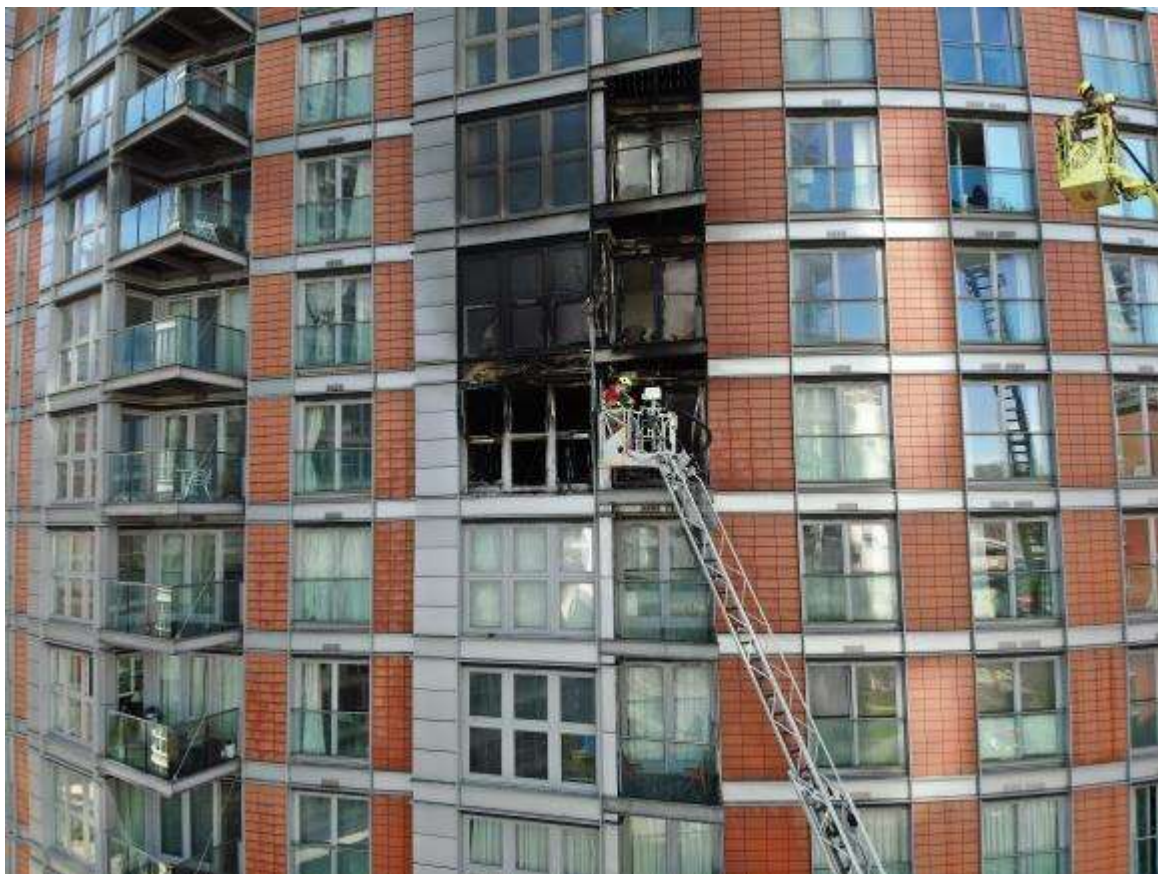
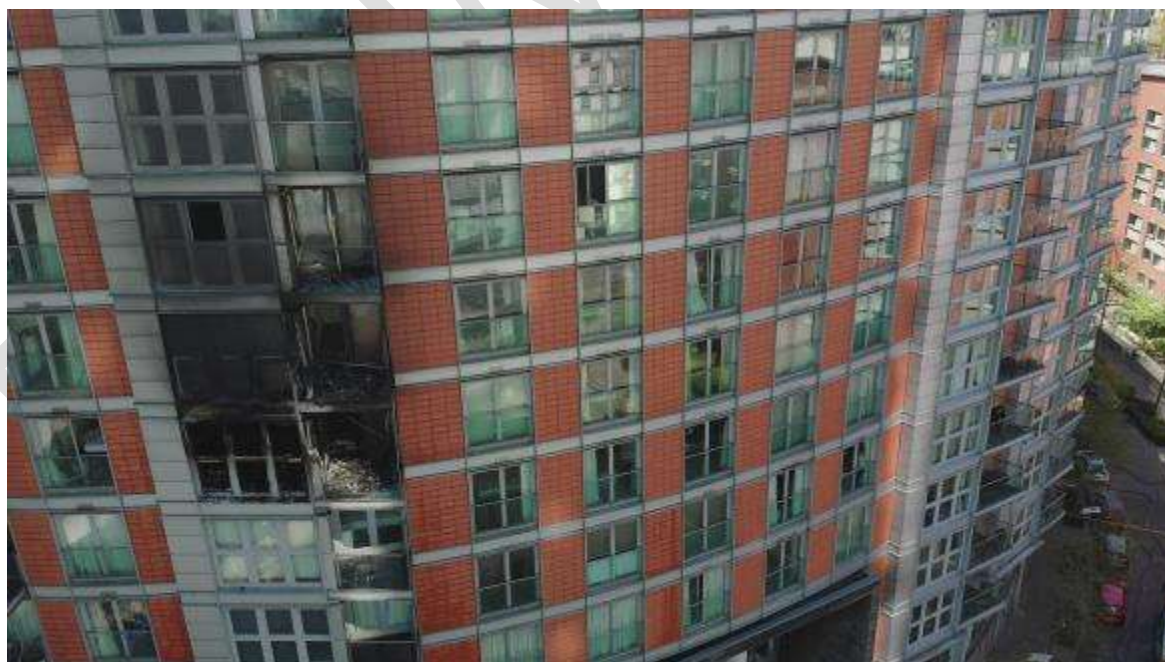
The flat of origin was approximately 80% damaged by fire. Fire spread externally up the building affecting balconies directly above on the 9th, 10th and 11th floors. The windows of the flat directly above on the 9th floor were also fire damaged. External ACM cladding on the 8th and 9th floors was also involved, but in this particular case, the cladding did not significantly add to the fire's development. All internal communal areas on the 8th floor were damaged by smoke, with fire and heat damage affecting the communal corridor around the entrance to the flat of origin. This was exacerbated due to the failure of the AOV

Images showing the damage to the exterior North face of NPW

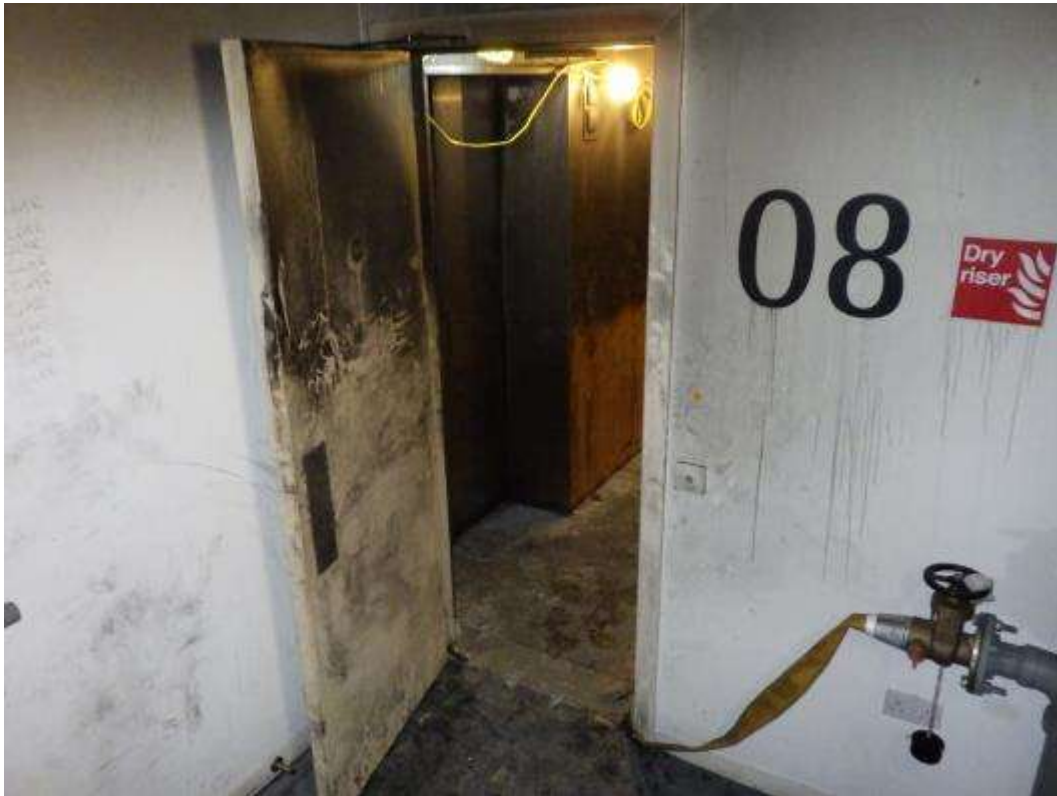
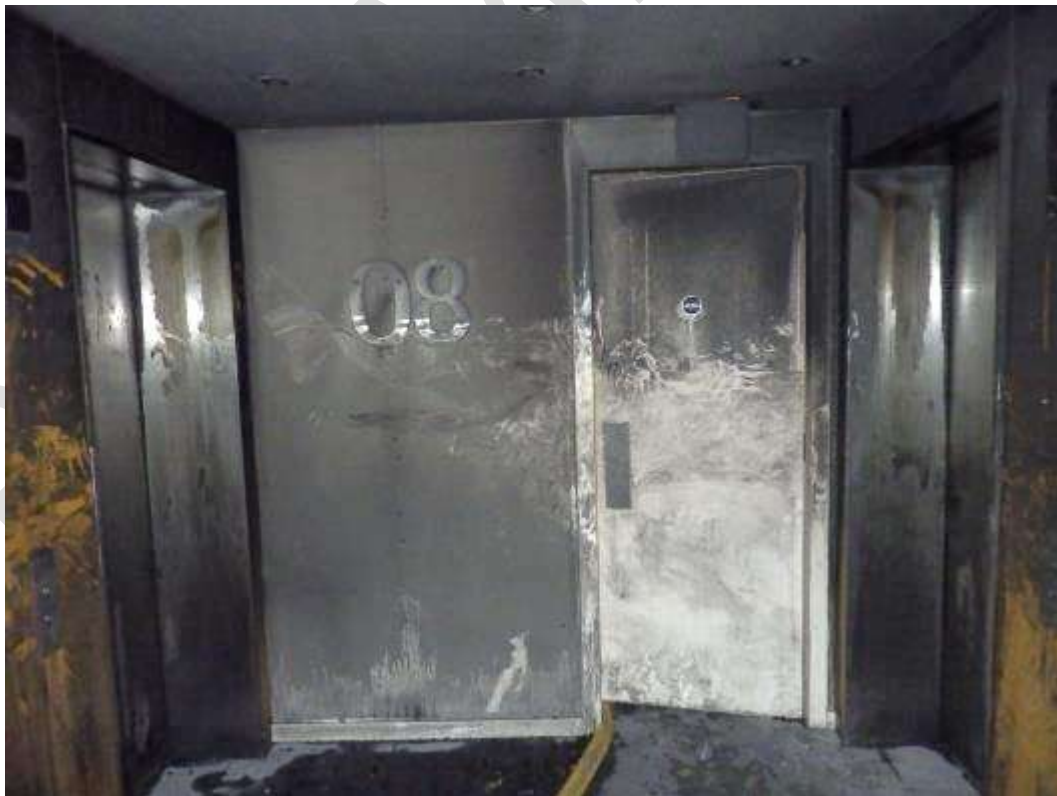
- 6.1.2 The 8th floor was accessed via the fire door between the stairs and the lift lobby. This door was heavily smoke stained across its top third on the side of the lift lobby, but the side facing the stairs remained relatively clean. The edge of the door was also relatively clean, indicating that it had held back smoke on the eighth floor and had only been compromised as people escaped the floor and once firefighters gained access.

Images showing the external and internal view of the door at the head of the 8th floor stairwell

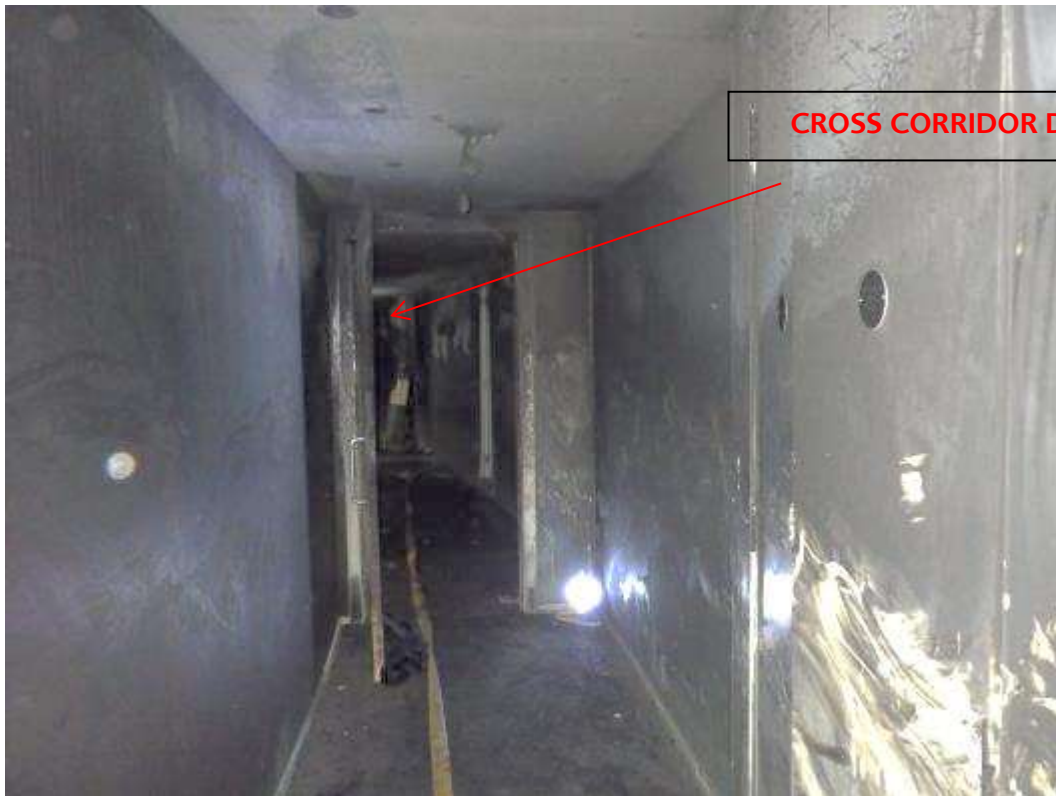
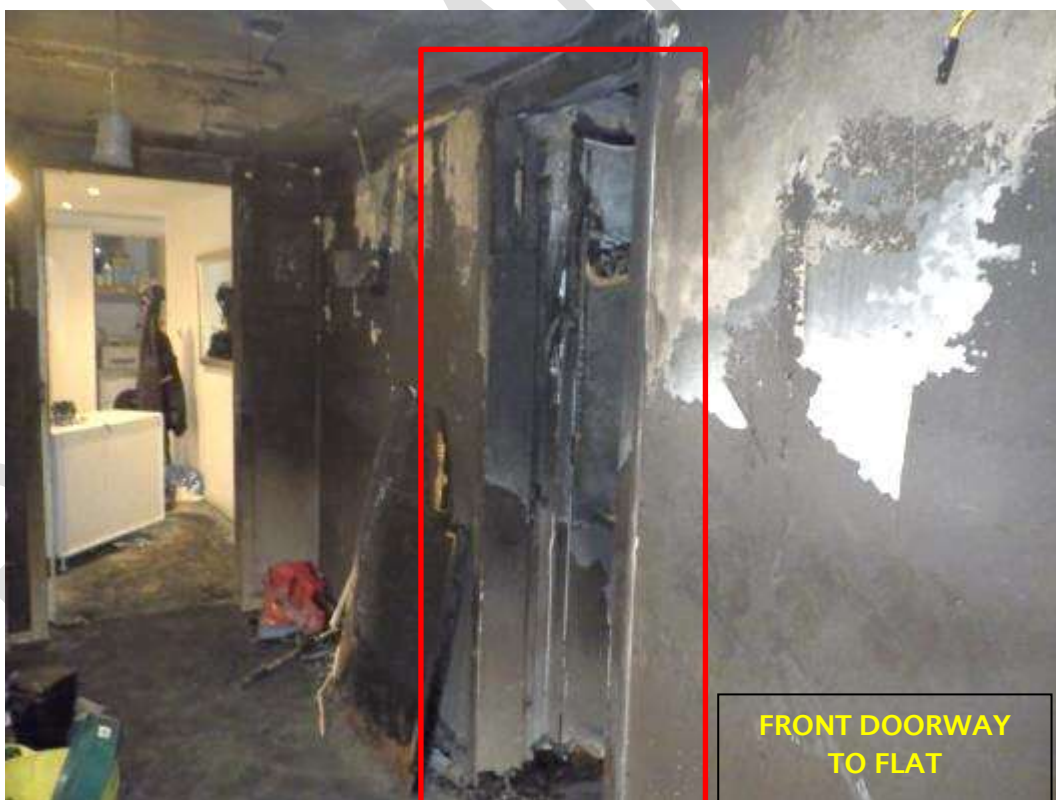
- 6.1.9 This corridor provided access to flats including the flat of origin. The 8th floor corridor was extensively damaged, with fire and heat damage to the ceiling and top surfaces of the walls, particularly outside the flat of origin.

Images showing the 8th floor corridor looking towards the flat of origin

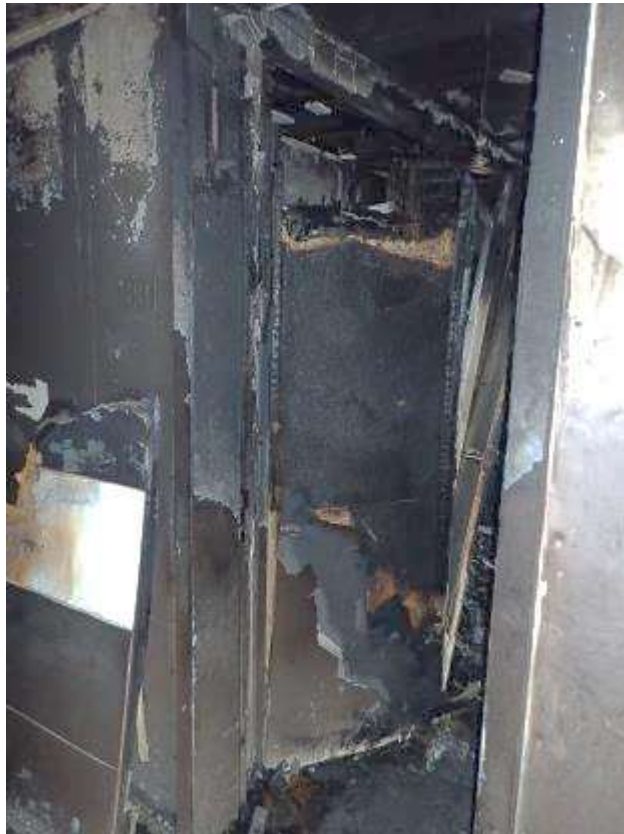
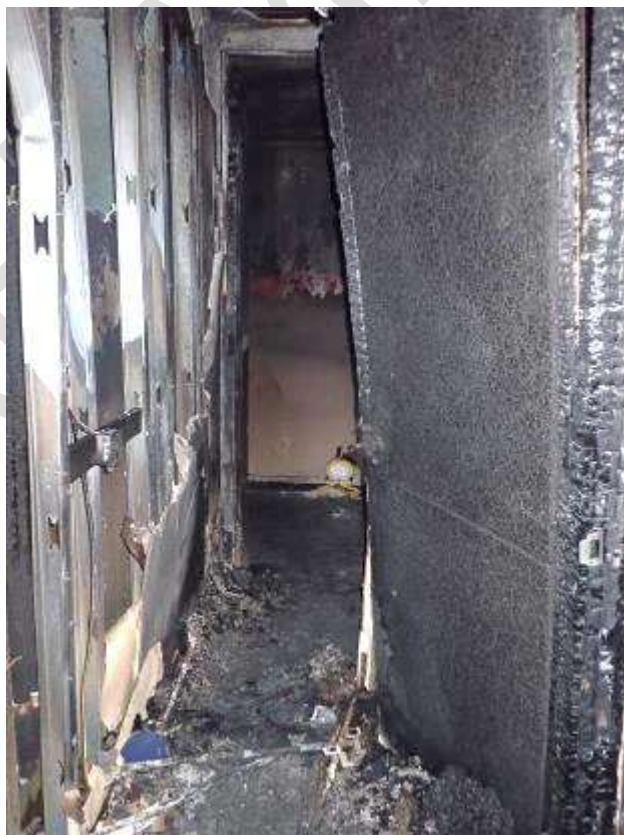
- 6.2 Examination of the flat of the fire's origin
- 6.2.1 The front door to the flat had been removed or fallen from its original position and had been placed in the communal corridor. The top half of this door had been consumed by fire. The inside face of the remainder of the door had an even charring. The outside face of the door was heat and smoke damaged to its top section. The self closing device for the door was found on the floor on the left hand side of the door frame. The upper sections of the door frame and timber boxed sections had been consumed by fire.

- 6.2.2 The front door led to a hallway, where the suspended ceiling plasterboard was missing, however the metal strut work was still in place. All cables within this void had been fire damaged. Towards the end of the hallway the concrete ceiling had spalled. On the right hand side of the hallway was the stud wall separating the kitchen. Apart from one small section at low level the majority of the plasterboard was missing. On the left hand side, initially there was a built in cupboard. The timber doors to this cupboard were charred on their exterior face and partially consumed on the top edge. The lower contents of this cupboard were mainly undamaged and consisted of a hot water cylinder and a washing machine. All cables that had been in the suspended ceiling above the cupboard were fire damaged.

*Images showing the front entrance (looking from outside) and hallway (looking from inside) of flat.
Note the remains of the door to the left of the doorway*

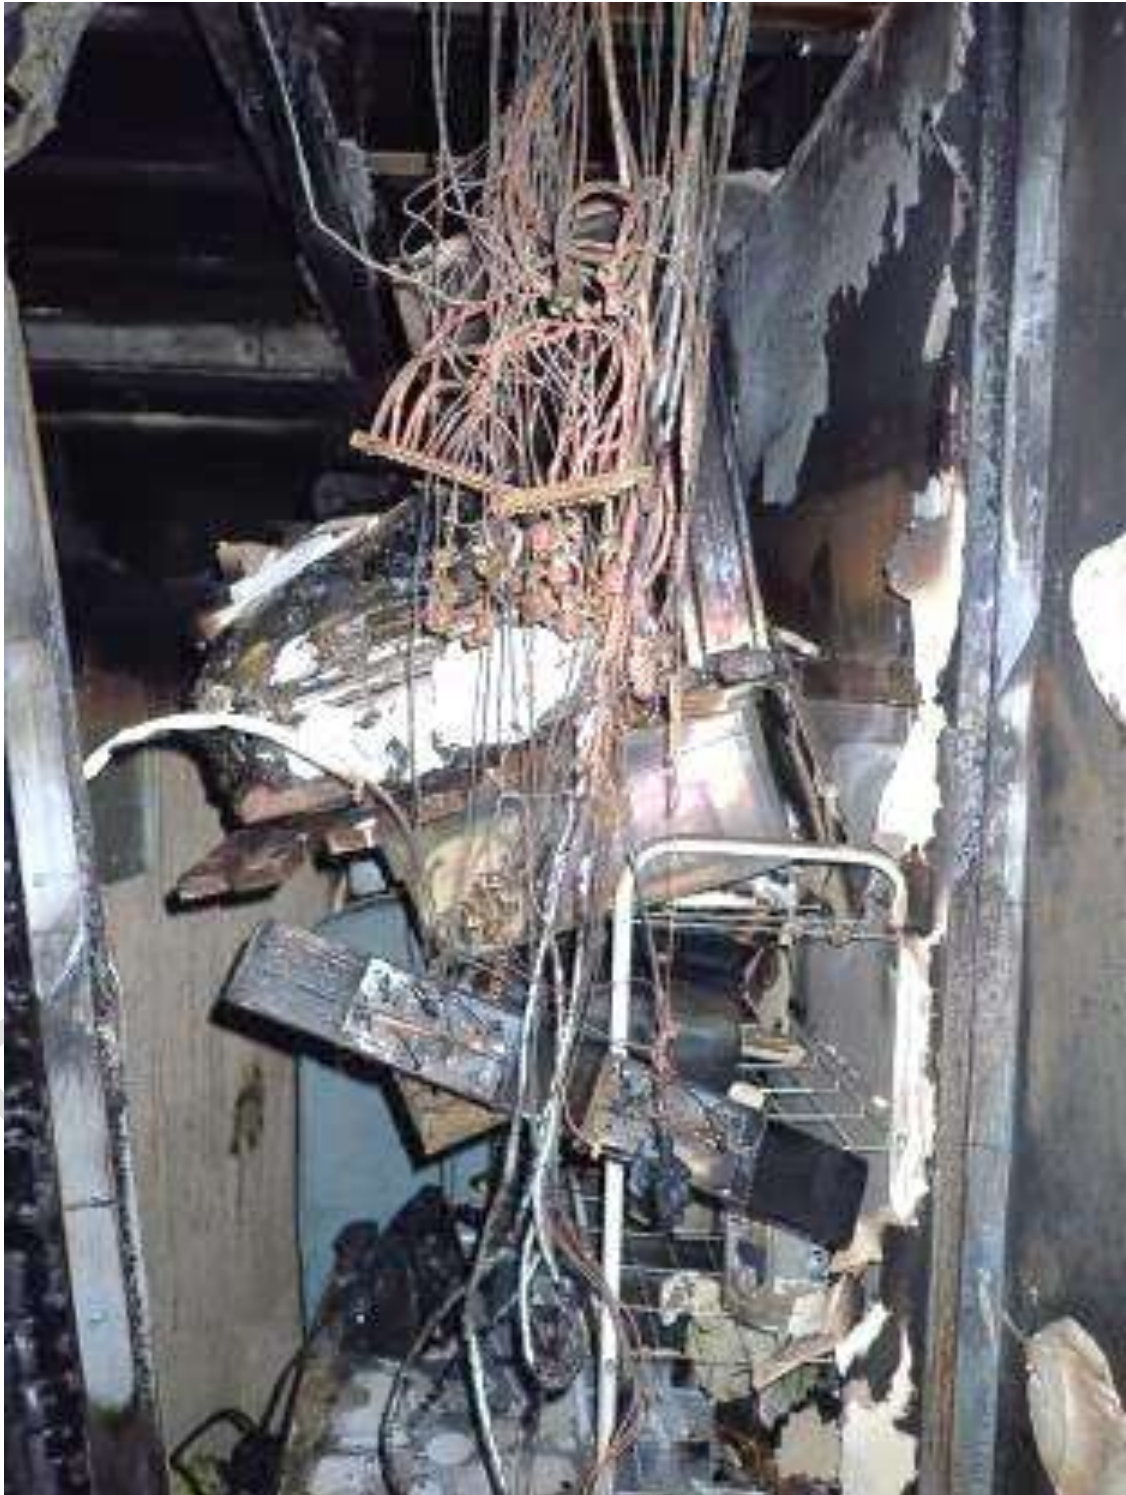
- 7.4.3 The consumer unit suffered 100% fire damage and had evidence of arcing damage to six of the circuits. There was also internal melting to the lower braid arm below the area where the timer switch for the hot water system would have been positioned.

Images showing the remains of the consumer unit in position

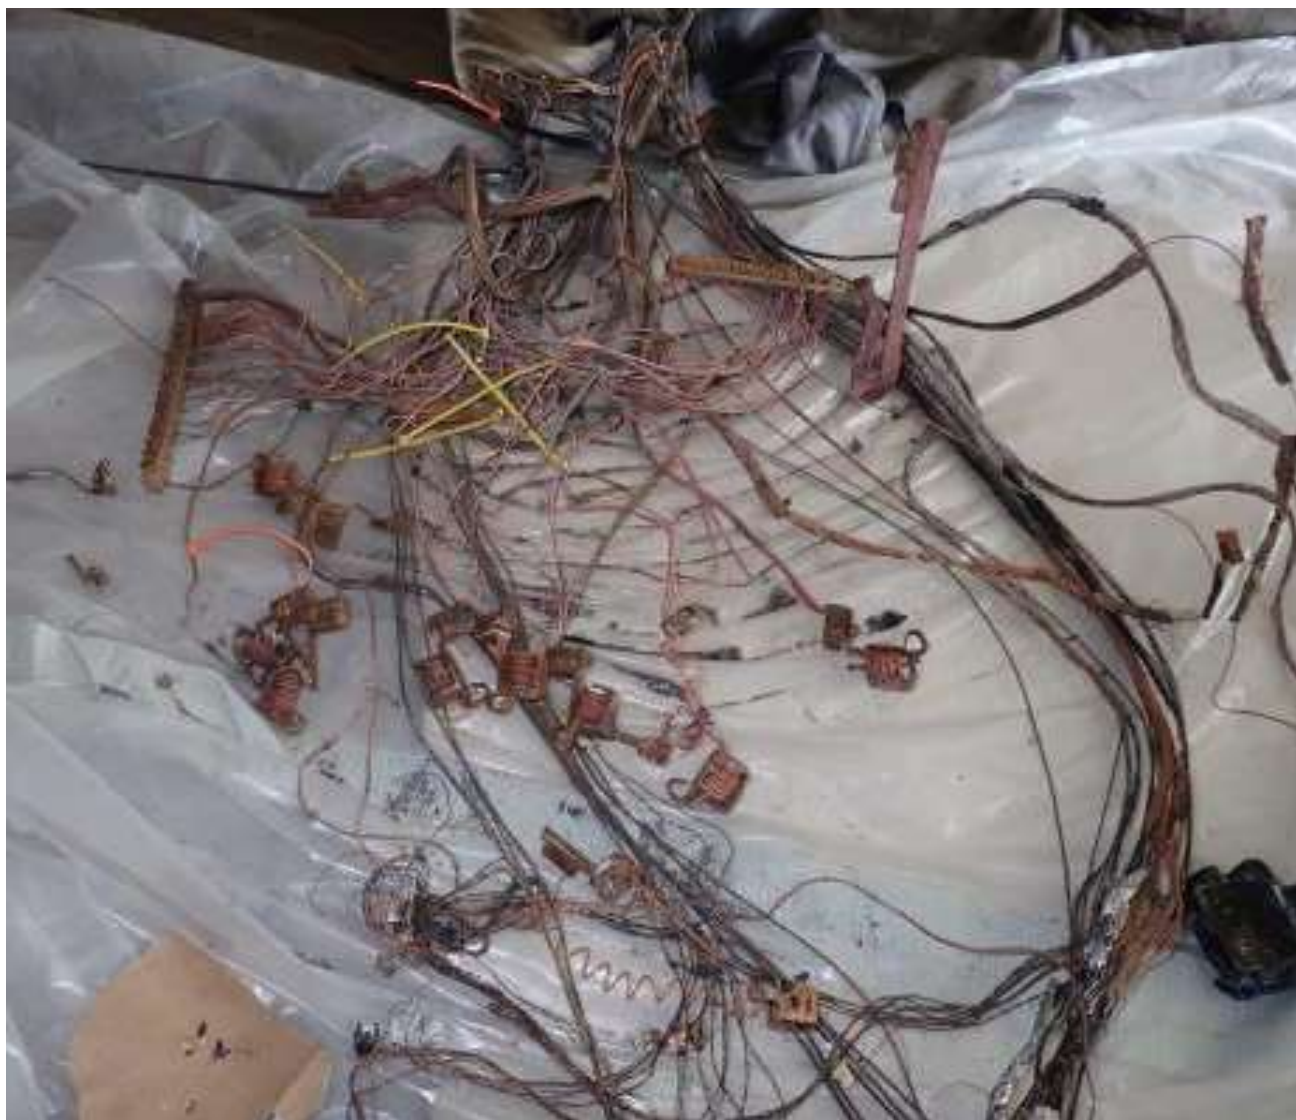
Image showing the remains of the top half of the consumer unit

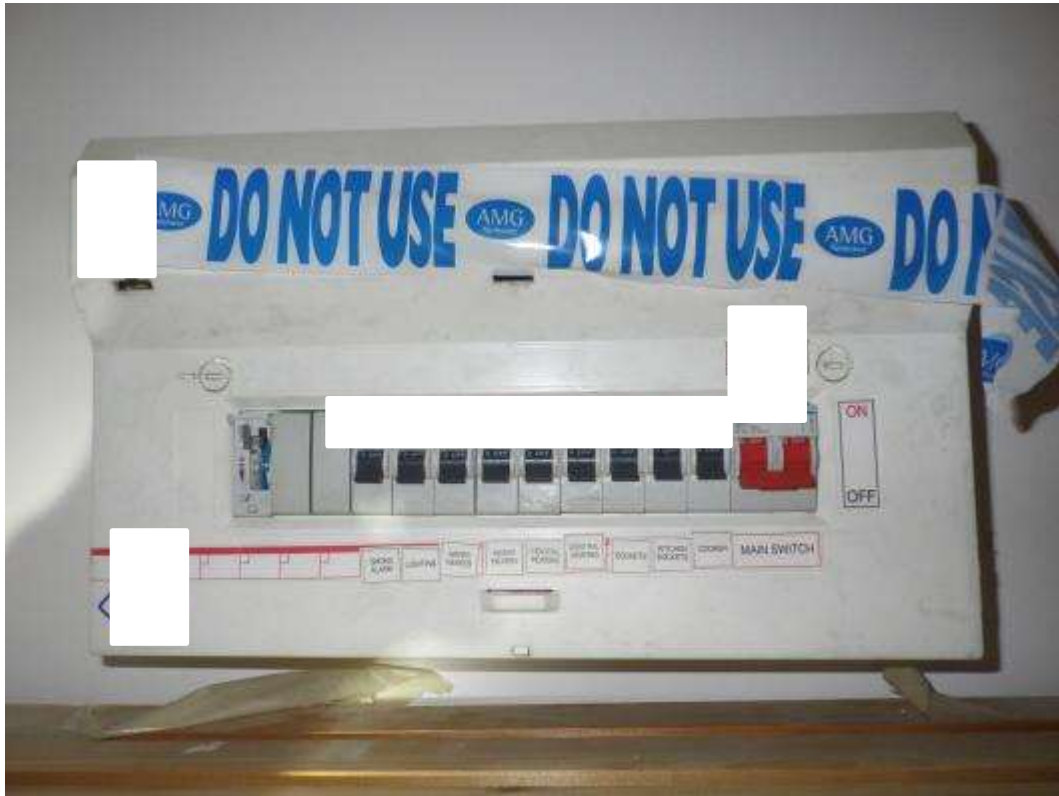
Image showing an exemplar consumer unit found in flat on 9th floor

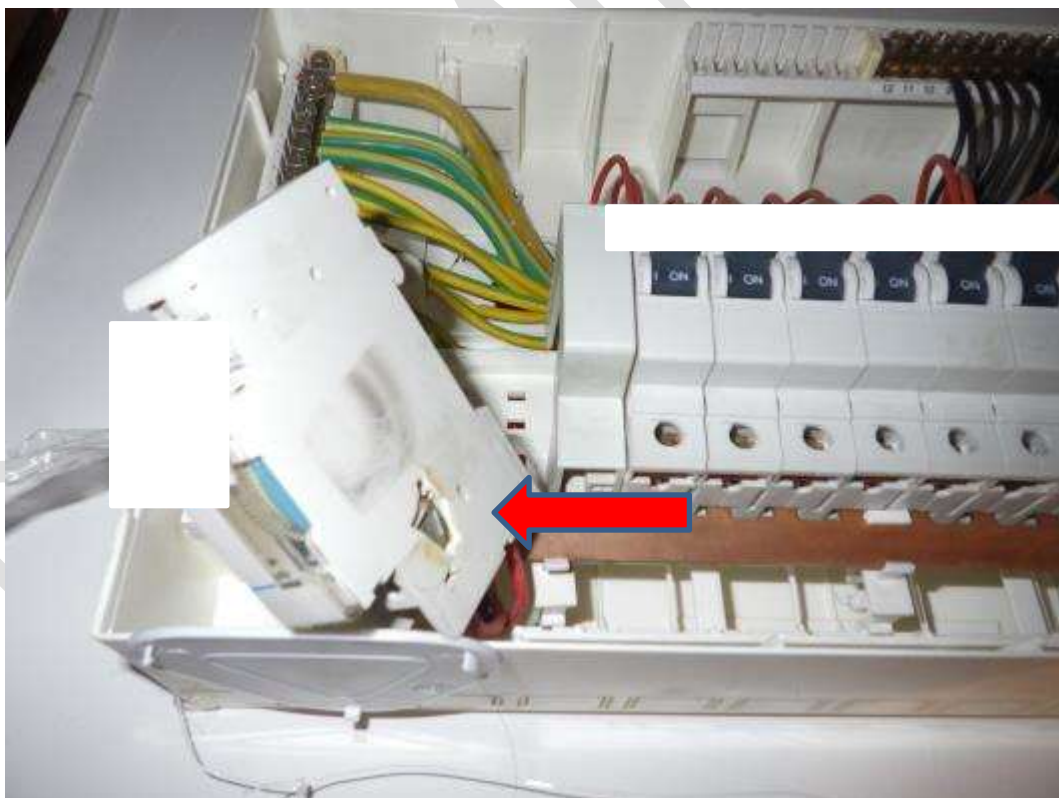
- 6.7.9 The original timer switches found on the 8th and 9th floors were then examined. In one flat where an original timer switch was found installed in a modern metal consumer unit, the timer switch was removed and a small burn was found on its side, adjacent to terminal 4. The red PVC insulation on the cable into terminal 4 was also blackened. This device was sampled for further examination by the Scientific Advisors, Bureau Veritas.

- 7.4.6 A survey of original consumer units installed in other flats within the block provided evidence that some of these timer switches were generating an internal heating fault, which was pyrolysing (heating) the plastic case of the switch.
- 7.4.7 The kitchen socket ring main apparently failed before the fire and was reported. The kitchen socket supplying the dishwasher was checked by investigators on the 10th May 2021; there was no signs of any unusual electrical activity on this part of the circuit.

Image showing an internal heating fault on the Timer Switch in exemplar flat

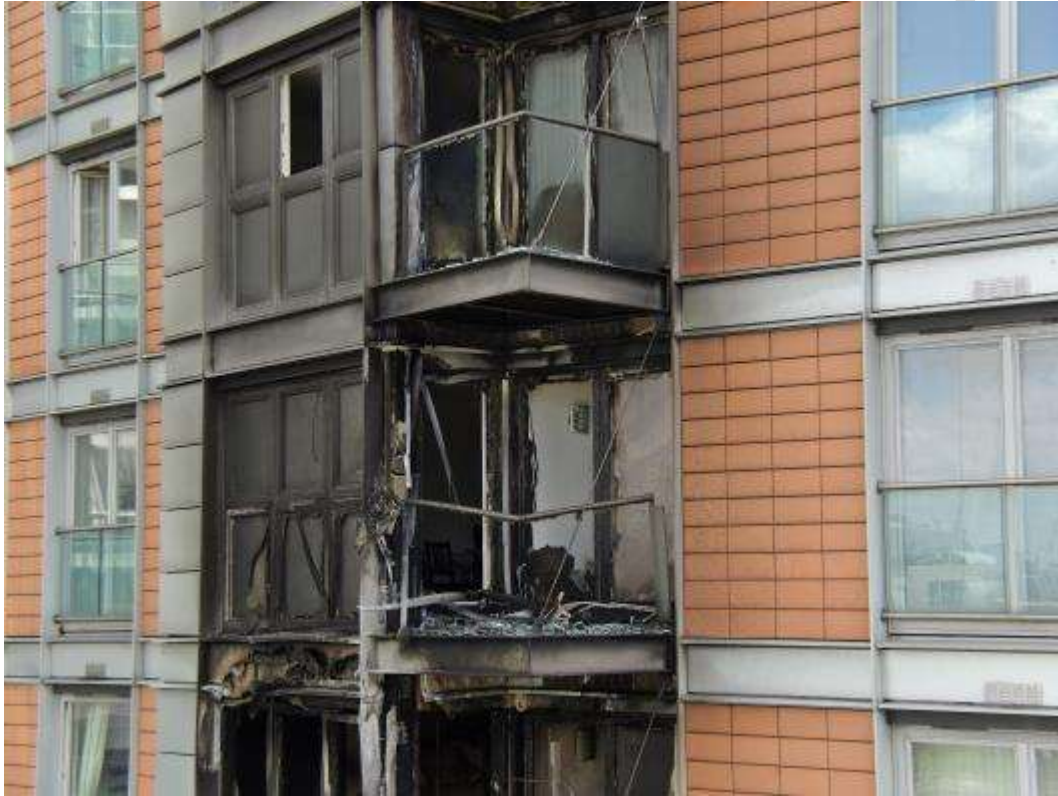
- 6.1.11 The flat located directly over the fire flat was examined. The fire had attacked the windows to the living room area and the doors to the balcony from the living room and second bedroom. Glass to both sets of doors to the balcony had broken, whilst the glazing to the living room windows was fractured but remained largely in place. The flat sustained only minor smoke damage internally, adjacent to the balcony doors.

- 6.1.12 The flat located two floors above the fire flat was examined. The exterior of the windows to the living room had been damaged by fire, but the glazing had not failed. The door between the living room and balcony had been fire damaged externally and the outer pane of its glazing had broken, but the inner pane remained intact, although fractured. The exterior of the door from the second bedroom to the balcony had sustained similar damage. There was no damage by fire, heat or smoke into the flat.

Image showing the external fire damage on the 9th and 10th floors

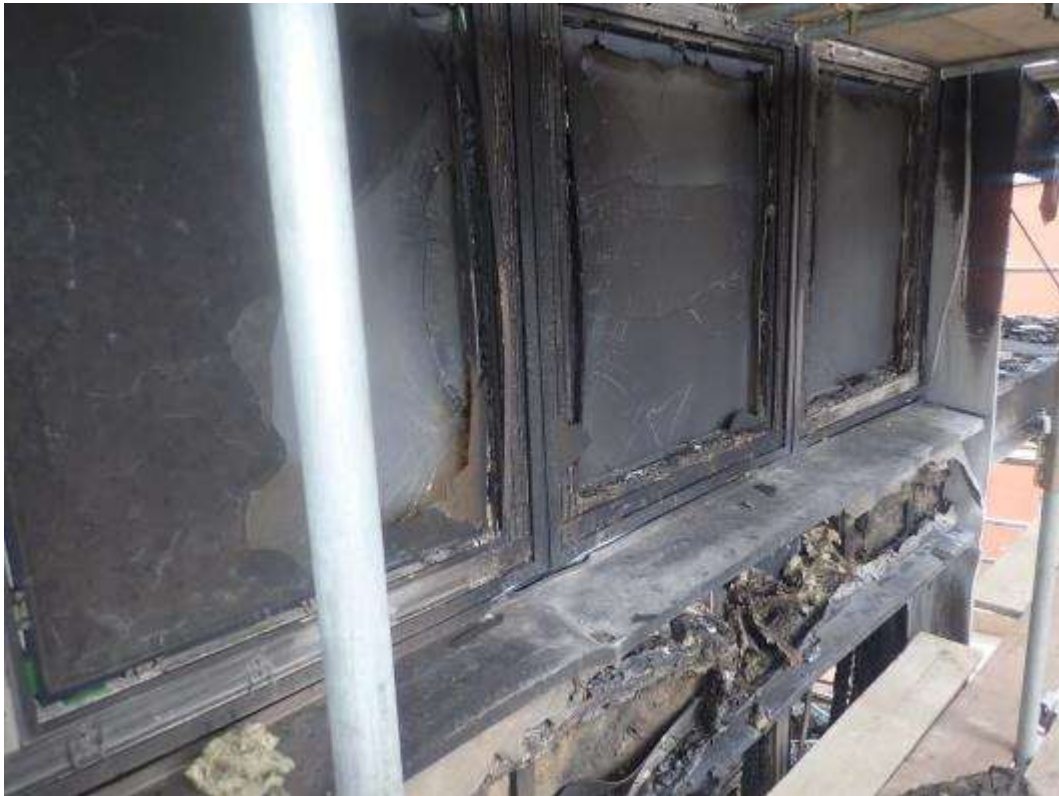
- 6.8.1 Exterior ACM panels were examined using an LFB aerial ladder platform. ACM panels were clipped in to a fixing at the bottom of the panel. The top of panels were fixed using pot rivets. Rivet heads were cut off and two panels were removed and brought to ground level for examination. A further section of fire damaged ACM cladding was removed from the right hand side of the balcony.

Image showing the damage to the ACM cladding between the 8th and 9th floor windows

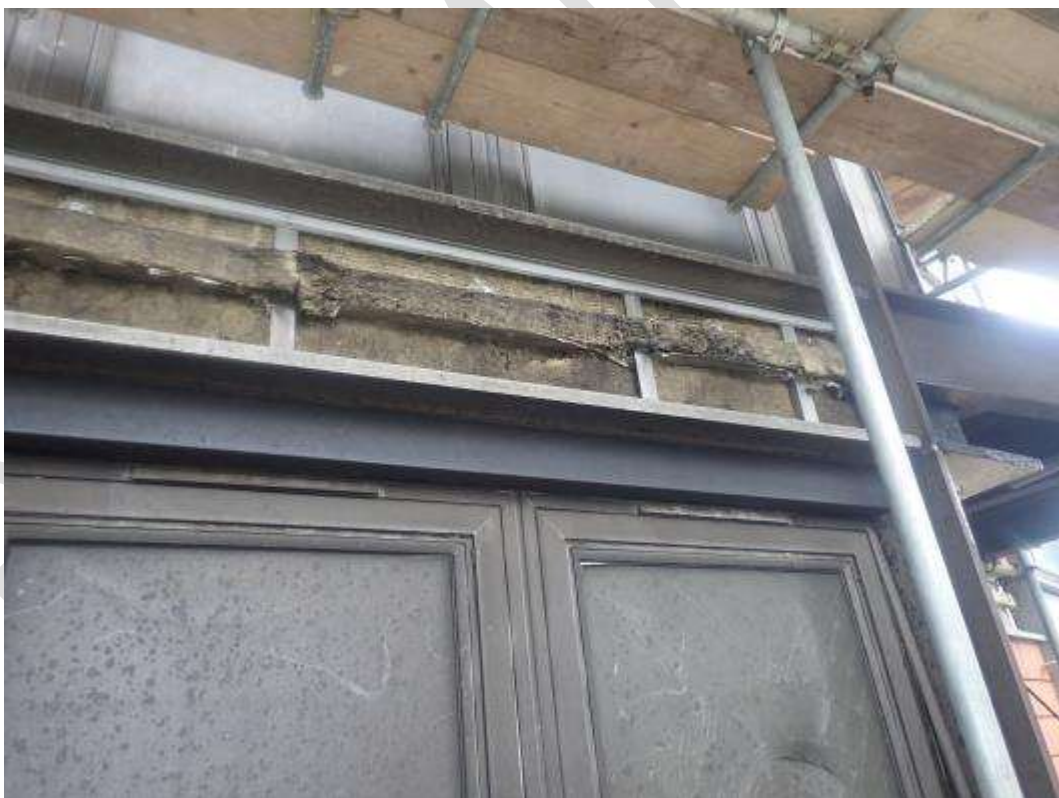
Image showing the internal construction of the ACM cladding between the 9th and 10th floors

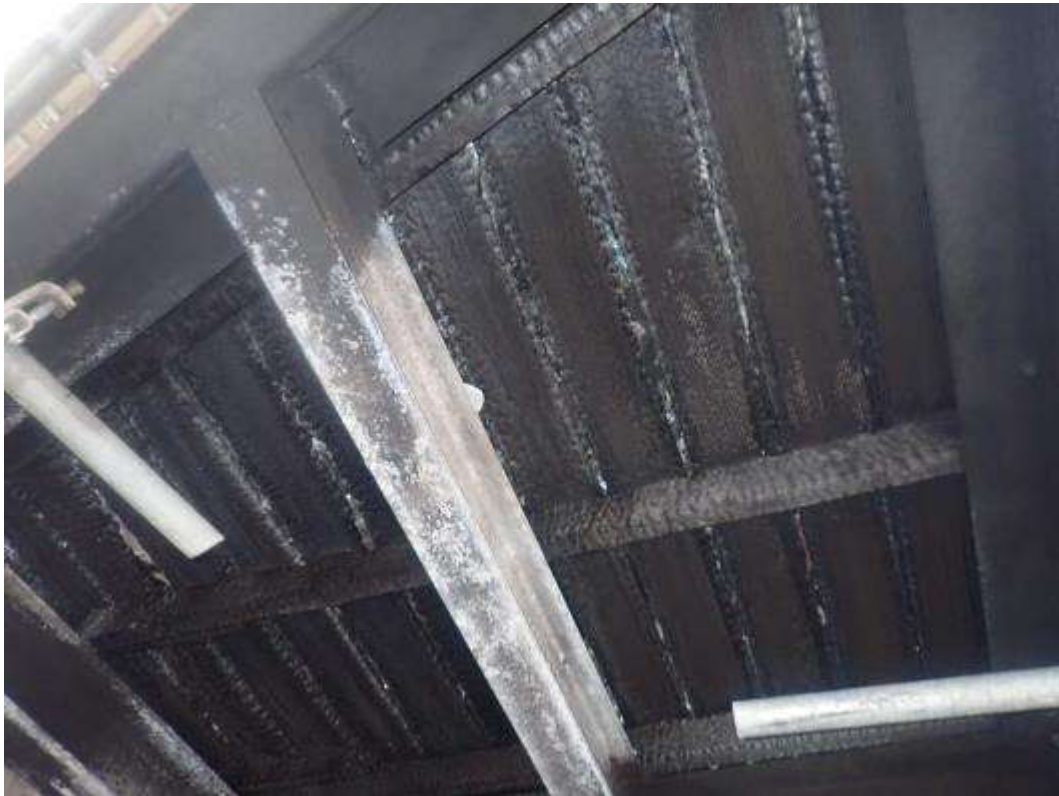
Image showing the charring to the underside of the 9th floor balcony timber decking

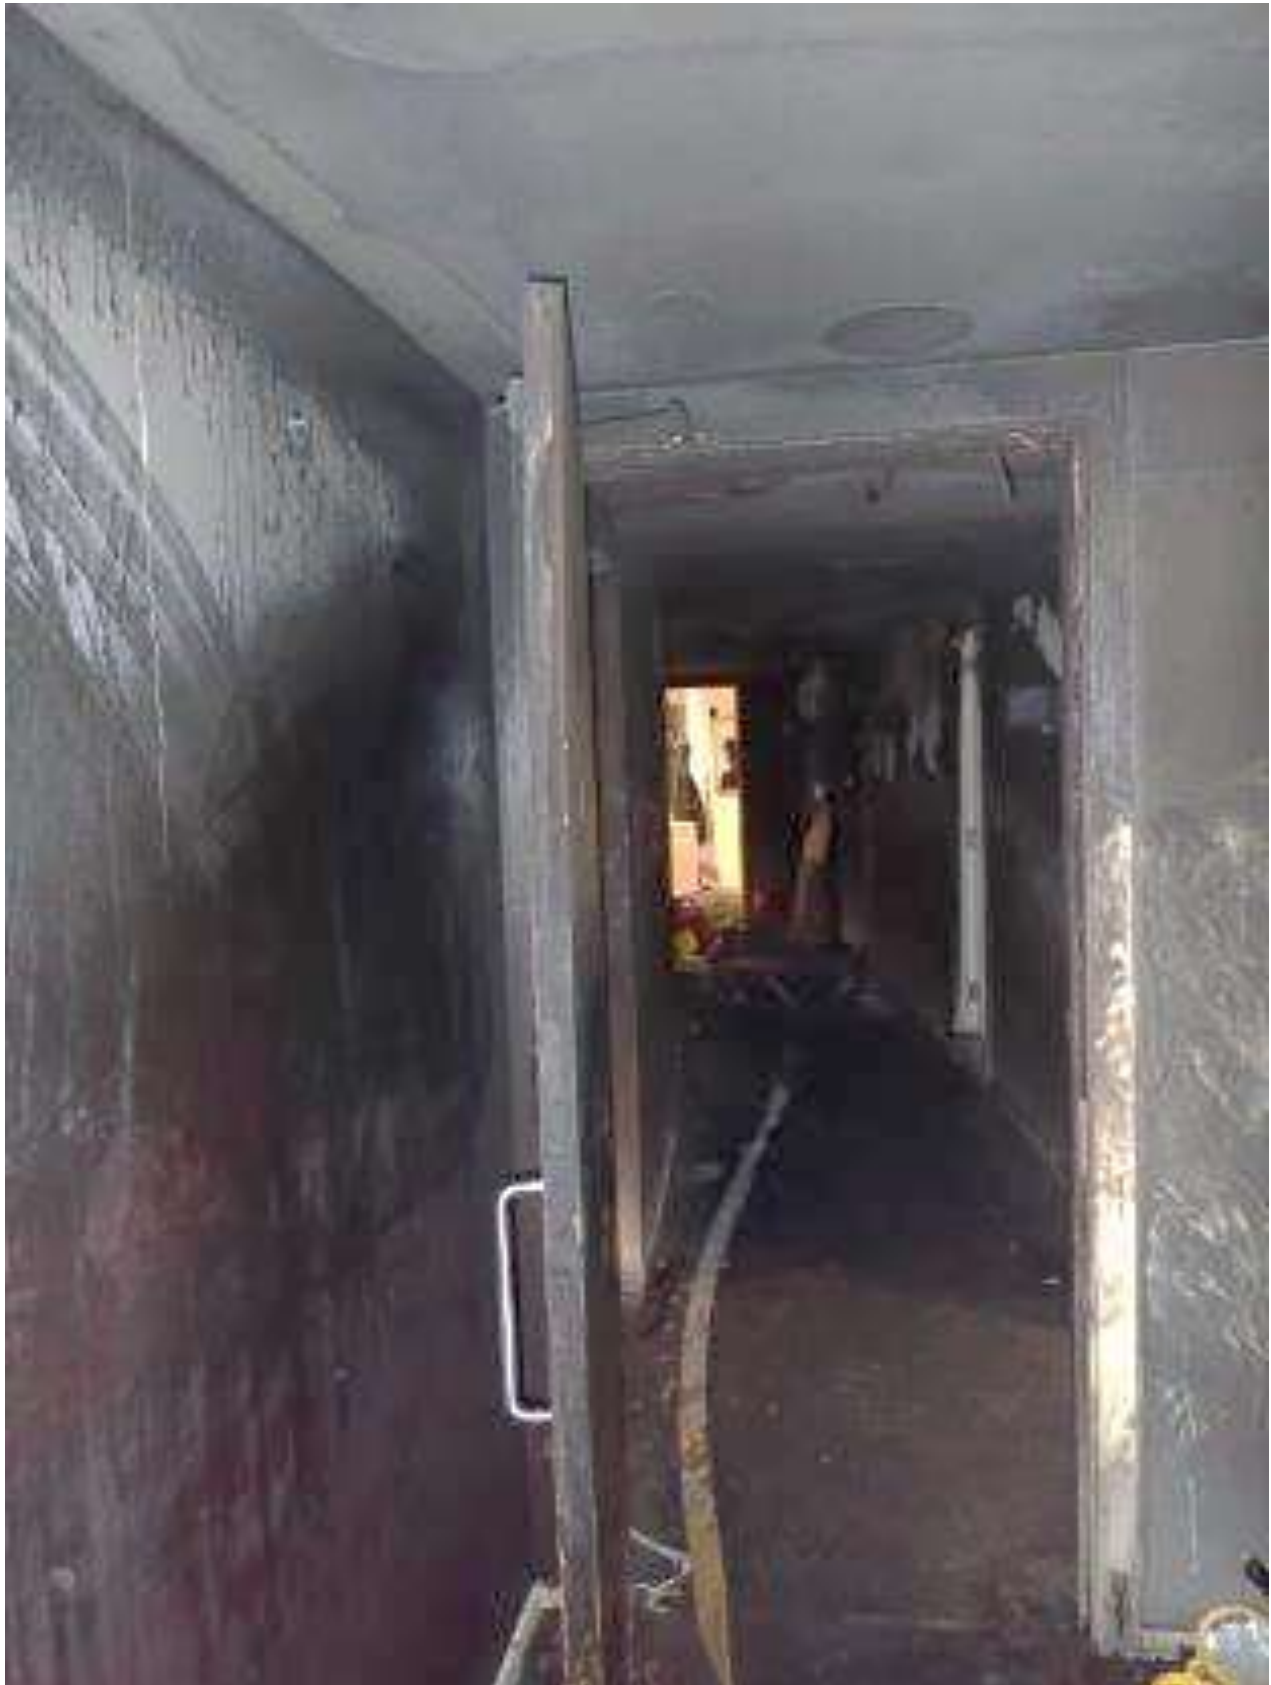
- 6.1.8 The corridor serving flats along the western side of the building was accessed via a fire door across the corridor. On other floors this door was held open on an electromagnetic door holder, but post-fire, this door was wedged open. Its magnetic door holder had been damaged and fallen to the floor. The top of the door had been damaged by heat and the whole door and wall surfaces adjacent to it were covered in a heavy layer of soot. The intumescent strip in the frame of this doorway was found to be expanded and charred, particularly around the top half of the door. The illuminated exit sign that had been mounted over this door in the corridor had been fire damaged and the plastic hanging sign was missing.

Image showing the cross corridor door on the 8th floor

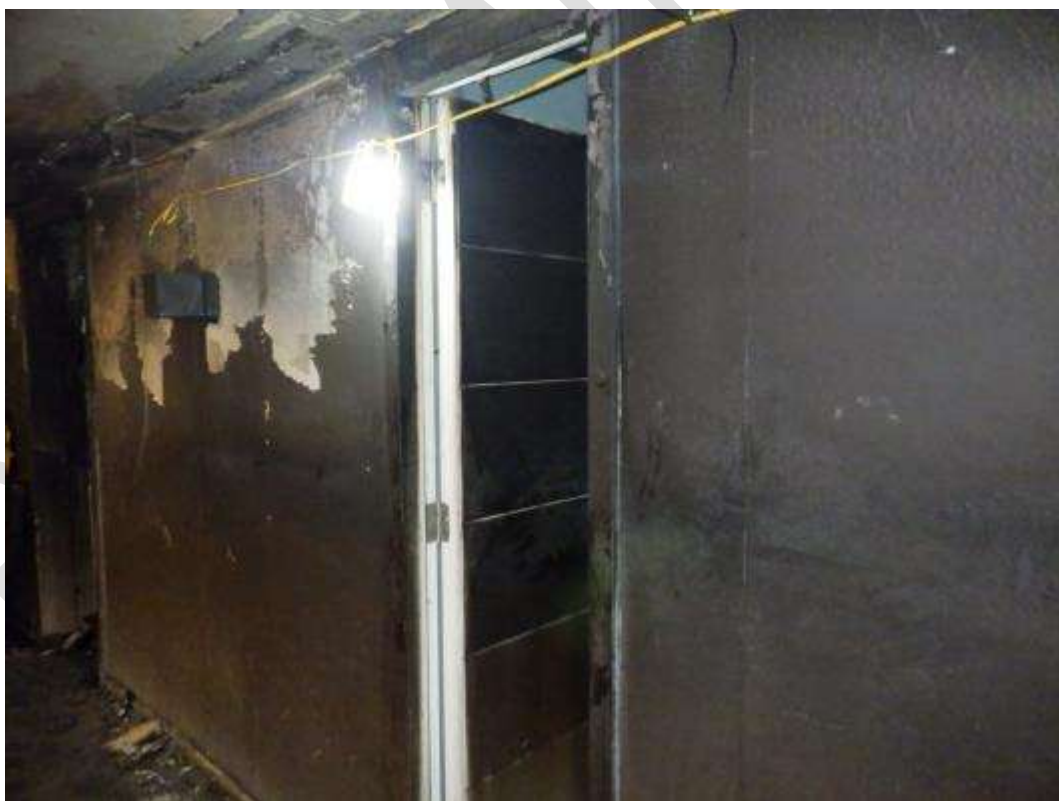
Image showing the AOV door on the 8th floor

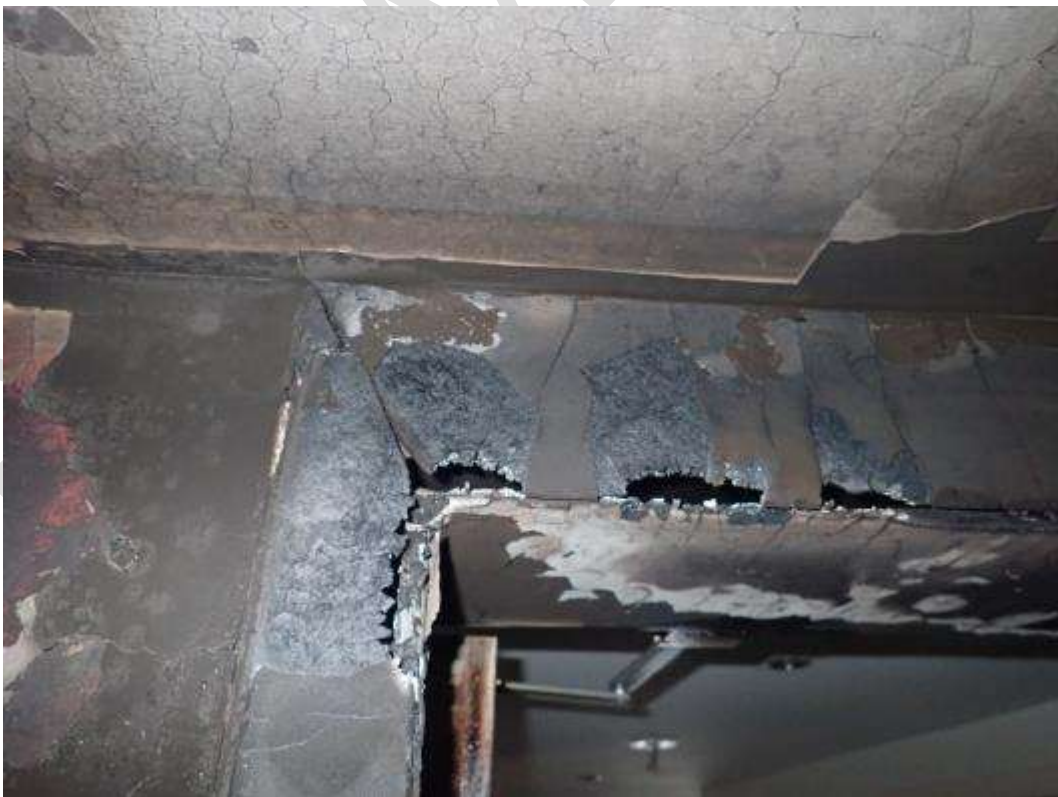
Image showing the timber boxing around the front door frame of flat next to flat of origin

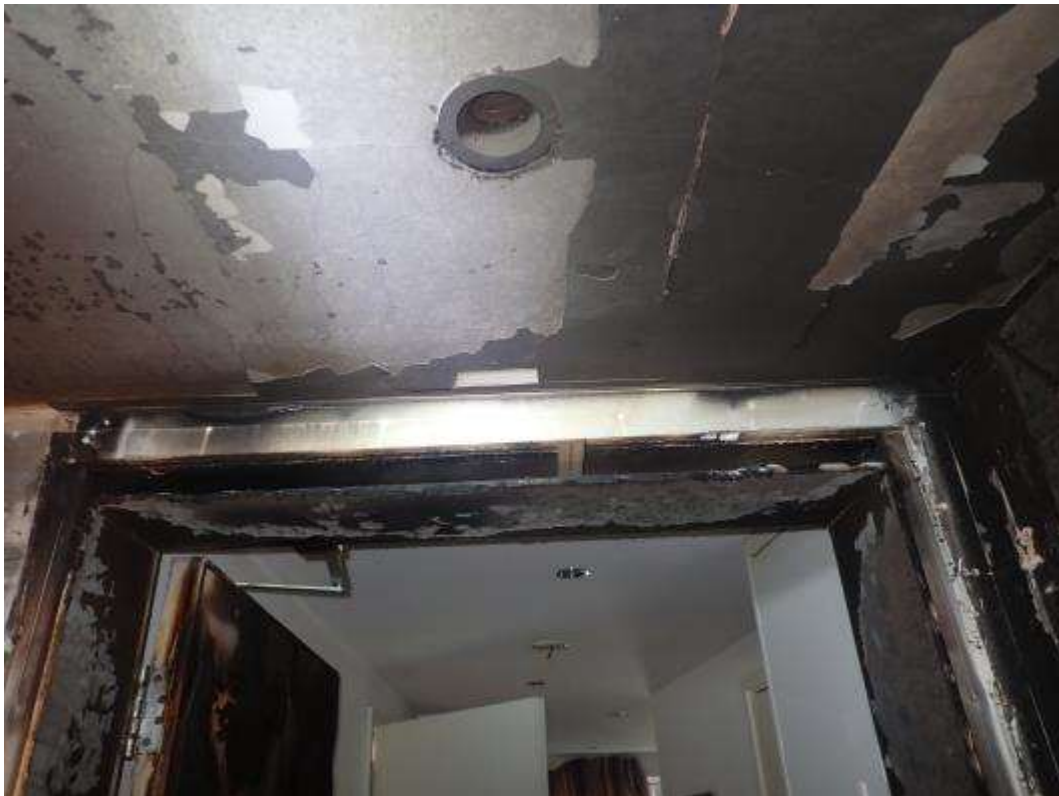
Image showing the void between the top of the door frame and the fabric of the building
