# Fire Safety Guidance Note: Fires in Communal Areas - Information for External Partners

**GN84**

Version: 3, 01 August 2023

### **Example 1 – Electric bike and associated lithium-ion battery pack fire in communal hallway.**

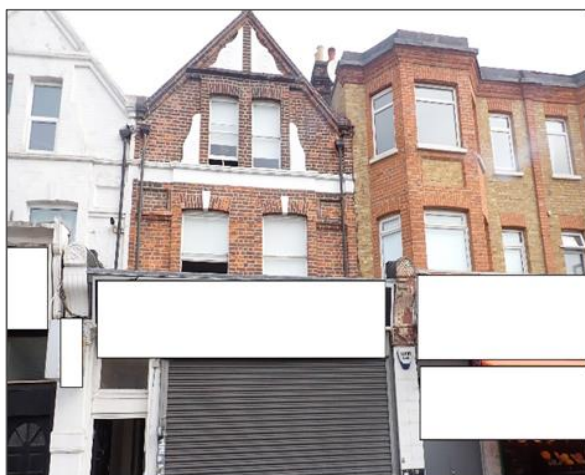
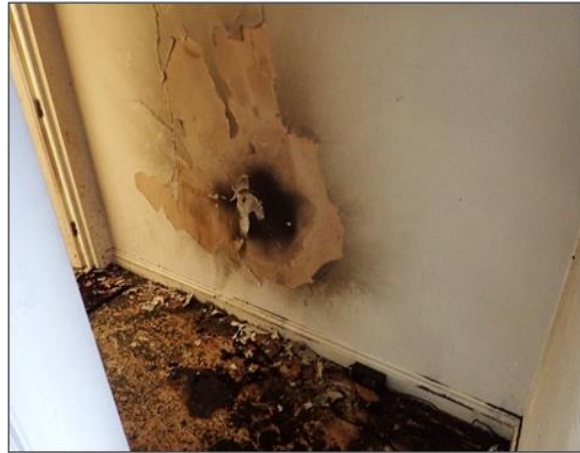
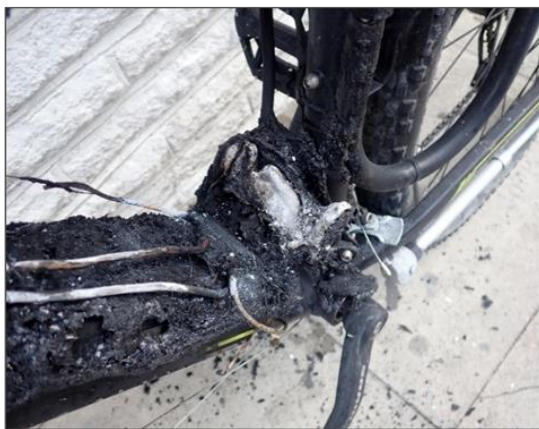
5.3 On arrival the fire brigade found the hallway smoke logged and the battery pack of the e-bike on the floor smoking. Firefighters removed the bike to the street (Seen in image right) and immersed the batteries in a bucket of water. The fire damaged the hallway, as seen in the images above.

5.5 Fire investigation attended the scene, the cause of this fire has been recorded as the failure of lithium-ion batteries.

5.6 A Senior Fire Safety Officer attended the scene and found minor fire safety issues around fire doors, escape route, fire safety management and detection and warning – factors which could potentially have increased the risk to residents had the fire been more severe.

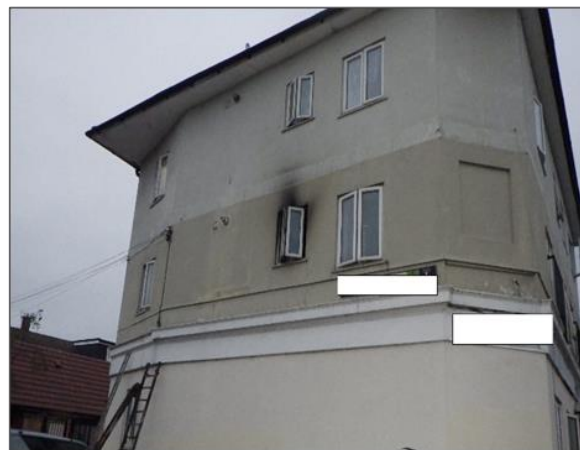
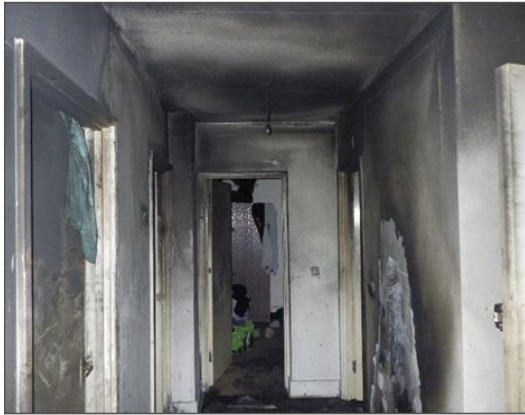
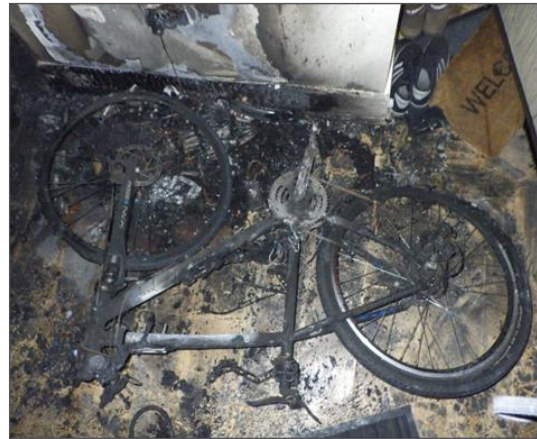
## Example 2 – Electric bike fire in hallway of an HMO.

5.9 The fire was discovered by the occupants when a smoke alarm actuated, and they could hear the fire. On opening their bedroom door, they found a fire in the hallway (as seen in the images). Some of the occupants then escaped out of the first-floor bedroom window with the remaining occupants leaving by the front door. On arrival firefighters saw smoke issuing from a side window and a group of people standing in the street. Firefighters extinguished the fire and searched the property.

5.10 The flat sustained significant damage by fire heat and smoke. Four adult males were removed to hospital suffering smoke inhalation with one further adult male treated on scene. Fire investigation attended the scene, the cause of this fire has been recorded as accidental due to failure of lithium-ion batteries from an e-bike on charge. A Senior Fire Safety Officer attended the scene.

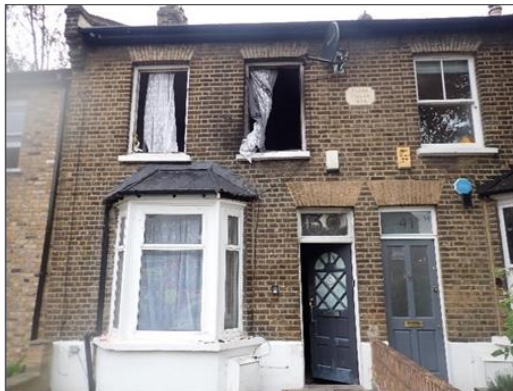
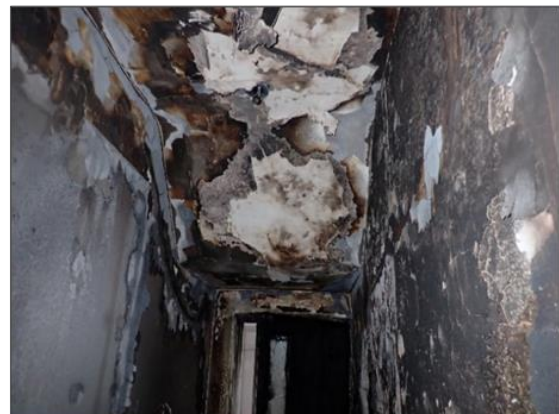
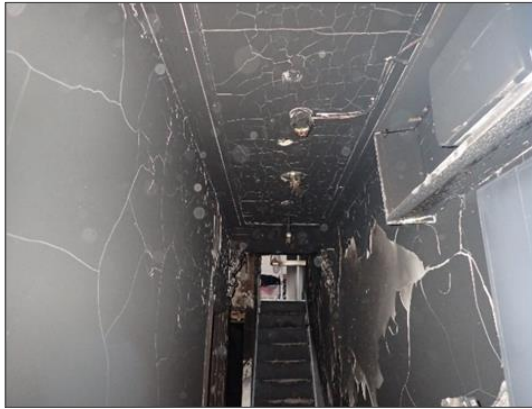
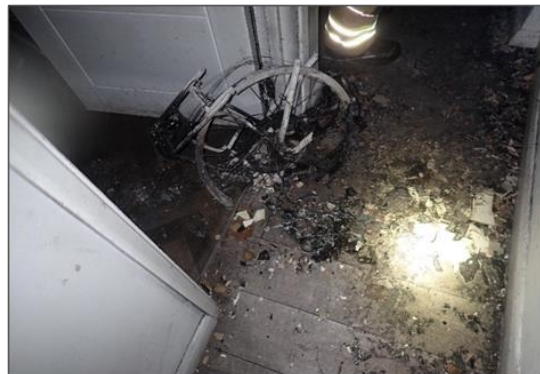
### **Example 3 – Electric bike fire in the communal hallway of a converted house into an HMO.**

5.13 On arrival the fire brigade found two residents on the canopy of the bay window and rescued them using a short extension ladder and extinguished the fire. The ground and first floor were significantly damaged by fire, as seen in the images.

5.15 Fire investigation attended the scene, the origin of the fire was located around an e-bike. A four-gang extension lead and transformer from a charger were also located in this area and were sampled by fire investigation.

5.16 A Senior Fire Safety Officer attended the scene and found fire safety issues.

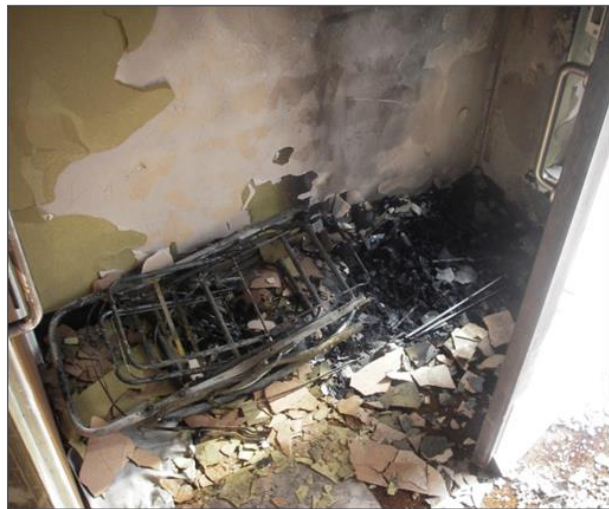
#### **Example 4 – Small buggy set alight in an entrance lobby of a modern low-rise block of flats.**

5.17 The image to the right shows a small buggy which was set alight in an entrance area to a low-rise residential block of flats. There was apparently very little additional fuel loading e.g. no toys and extra blankets.

5.18 The damage to the ceiling, plaster work, décor and electrics in the area would have resulted in a significant repair cost. It was lucky that no one came out of their flats during the fire, as there would have been significant amounts of toxic smoke and hot fire gases.

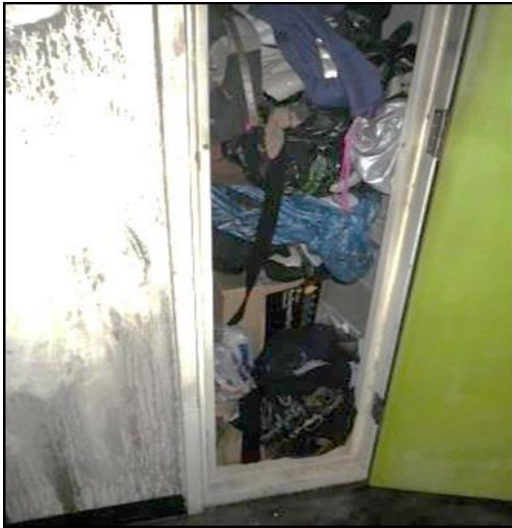
**Example 5 – Small cupboard in internal hallway in a high-rise block of flats. Domestic items belonging to one of the residents were stored in it.**

5.22 The three images on this example relate to a fire which occurred in a common lobby shared by four flats on the second floor of a high-rise block. The seat of the fire was within a small cupboard (approximately 30-50cm wide) used to house services such as drainage and telephone cables. The cupboard had been filled with old clothes and electrical items (*example image left*).

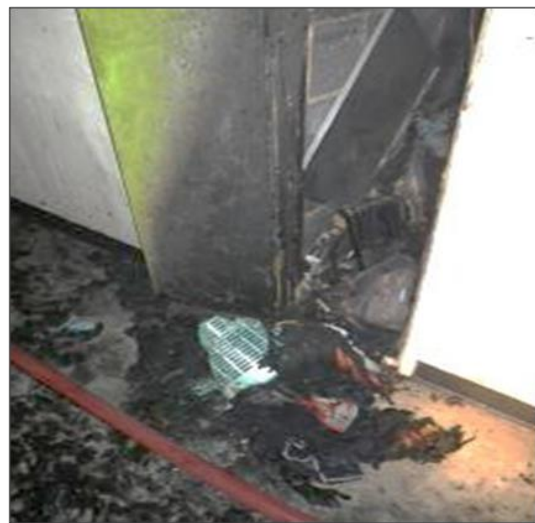
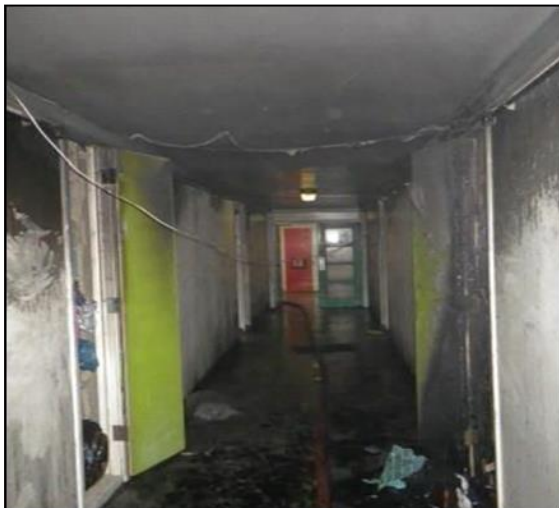
5.25 The image to the right shows the cupboard with some fire debris removed. There was not a huge amount of material involved, considering the extensive smoke damage, as seen in the image below.

5.27 The fire was confined to the area of origin with the remainder of the lobby and corridor being damaged by heat and smoke.

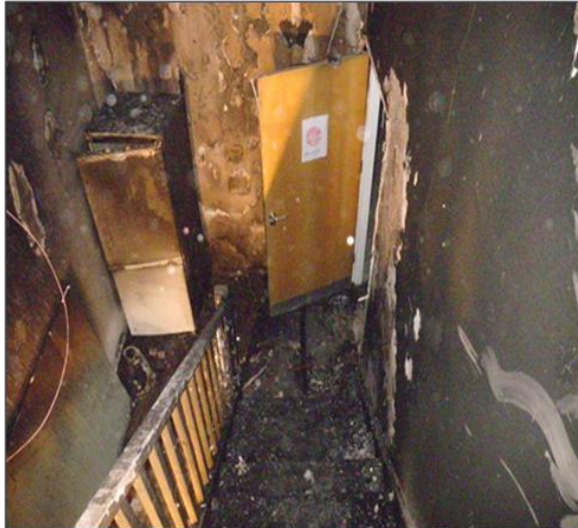
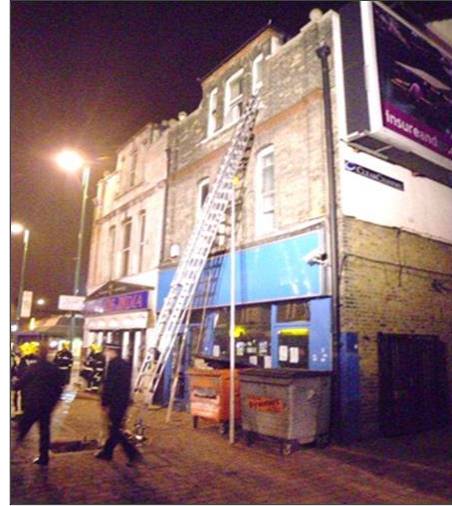
**Example 6 – Papers & stored goods in a mixed-use semi-detached building of three floors.**

5.30 The fire started in the hallway on the ground floor offices at the base of the internal staircase to the flats (as shown in image to the left) and damaged approximately 50% of the ground floor. The remainder of the ground floor was damaged by heat and smoke, with the rest of the building damaged by smoke. The fire was attended by four fire engines.

building at the time of the fire. All were unable to escape from the building. Two were rescued from a first-floor window by a road contractor, who put the bucket of his JCB up to the window prior to the arrival of the Brigade. The other five were rescued from a second-floor window by the Brigade with a ladder (as seen in image to the right, with Brigade ladder in situ). All seven were removed to hospital by the London Ambulance Service, suffering from smoke inhalation.

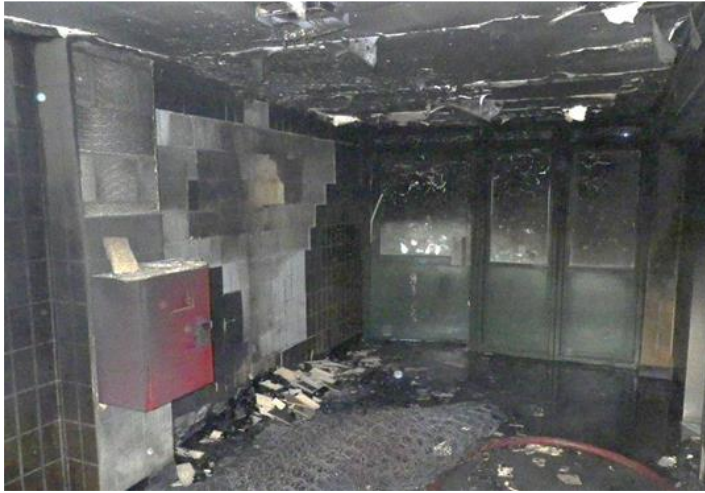
*Image left: View of communal area with the remains of the mattress in foreground. Note damage to ceiling and walls, doors and wall panels.*

*Image right: View from other side of doors. Note extensive damage to ceiling, walls, doors and wall panels. Light fitting and electrical wiring indicated by red arrow also damaged by fire.*

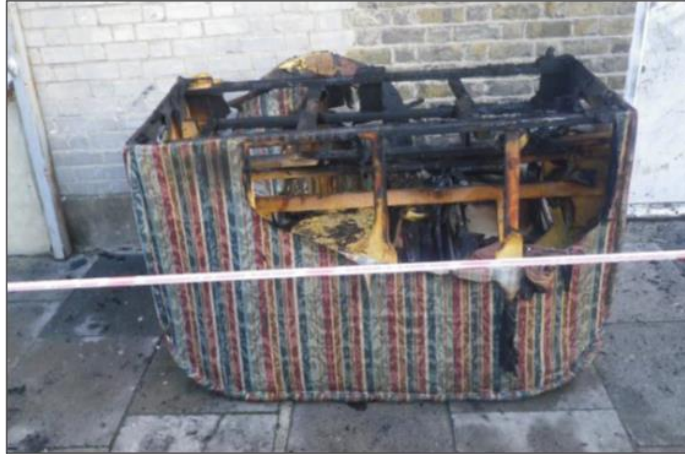
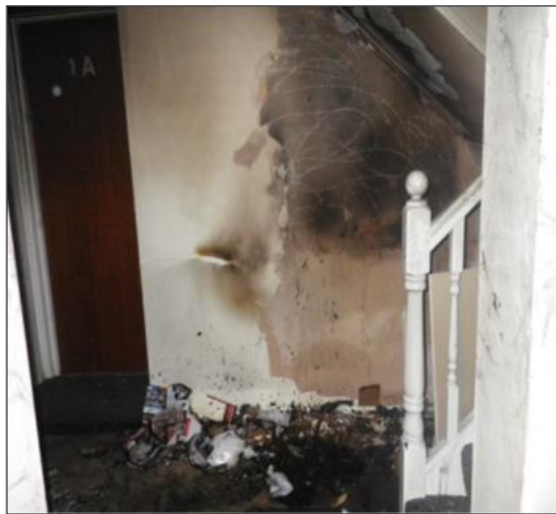
### **Example 8 – Papers on a small sofa which was left in a ground floor communal area of a low-rise block of flats.**

5.39 The image (to right) shows the area of origin where the sofa was. Note that the structural damage was not particularly severe in this case, but the smoke travel resulted in the rescues and injuries detailed above.

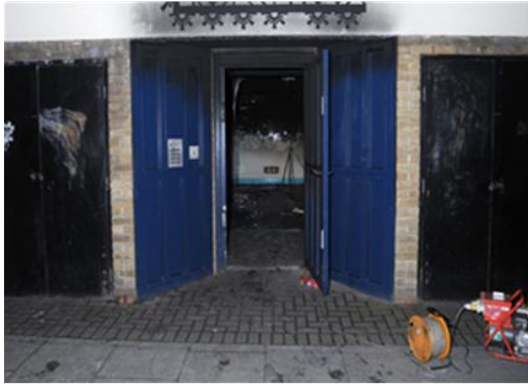
*View of front communal entrance*

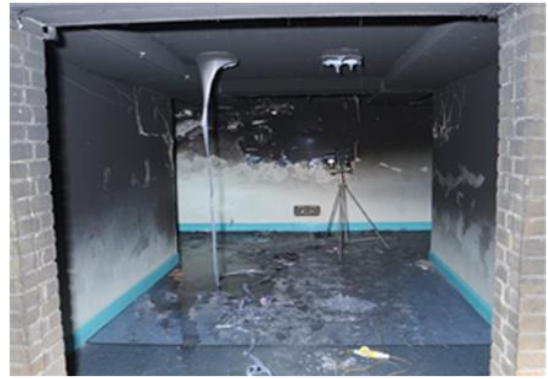
*View going in through the communal entrance. Note light fittings have melted*

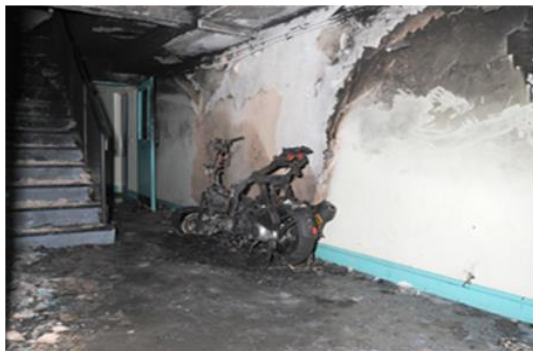
*Clear burn pattern behind the scooter  
Note: rear tyre is still intact*

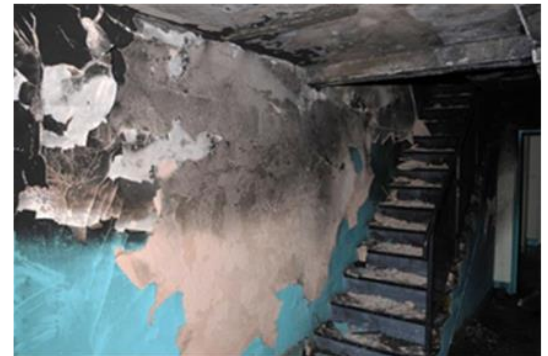
*Stairwell opposite the scooter. Note: spalled plaster from the stairwell has fallen onto the stairs*

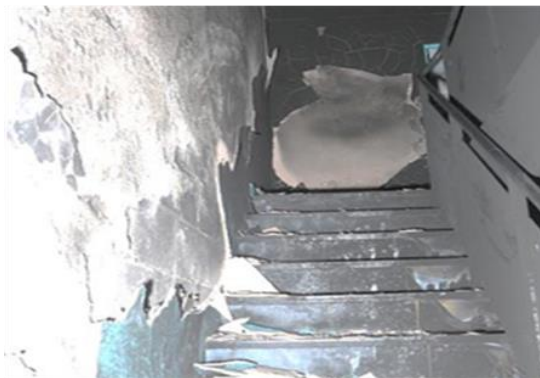
*Image to left: View upstairs showing extensive heat and smoke damage.*
