LONDON FIRE BRIGADE

FIRE SAFETY GUIDANCE NOTE

Fires in Communal Areas - Information for External Partners

GN84

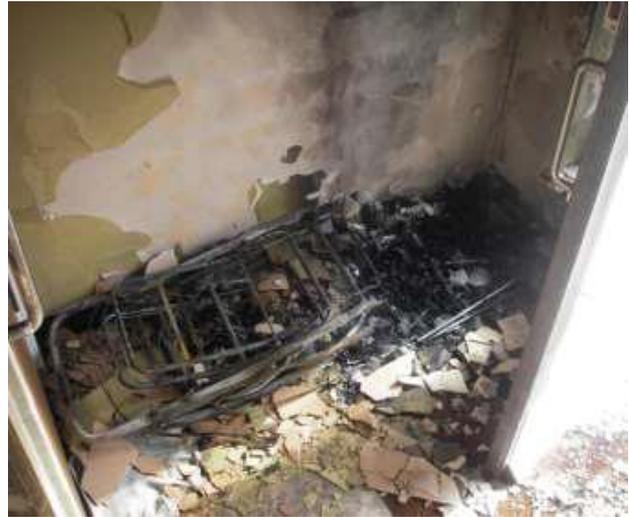
4.1 The image to the right shows a small buggy which was set alight in a very modern entrance area to a low rise block served by a single staircase and entrance. There was apparently very little additional fuel loading e.g. no toys and extra blankets.

4.2 The damage to the ceiling, plaster work, décor and electrics in the area would have resulted in a significant repair cost. It was lucky that no one came out of their flats during the fire, as there would have been significant amounts of toxic smoke and hot fire gases.

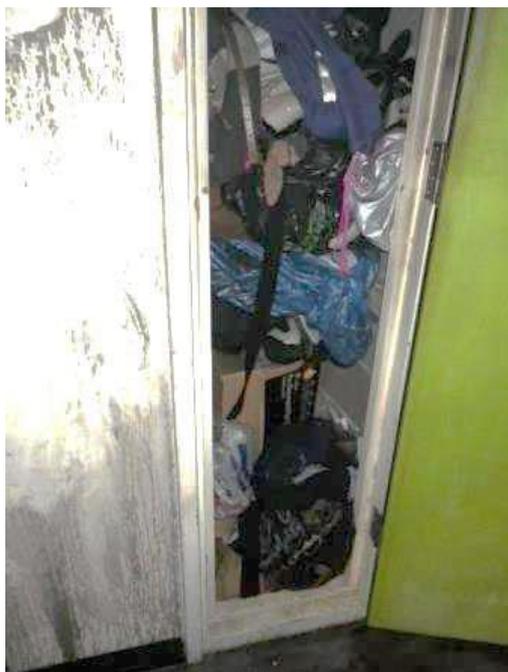
4.6 The three images on this page relate to a fire which occurred in a common lobby shared by 4 flats on the second floor of a high rise block. The seat of the fire was within a small cupboard (approximately 30-50cm wide) used to house services such as drainage and telephone cables. The cupboard had been filled with old clothes and electrical items (example image left).

Note: Risers in common areas should be kept locked shut to prevent inappropriate storage in these areas. This should be part of ongoing management / maintenance of the building.

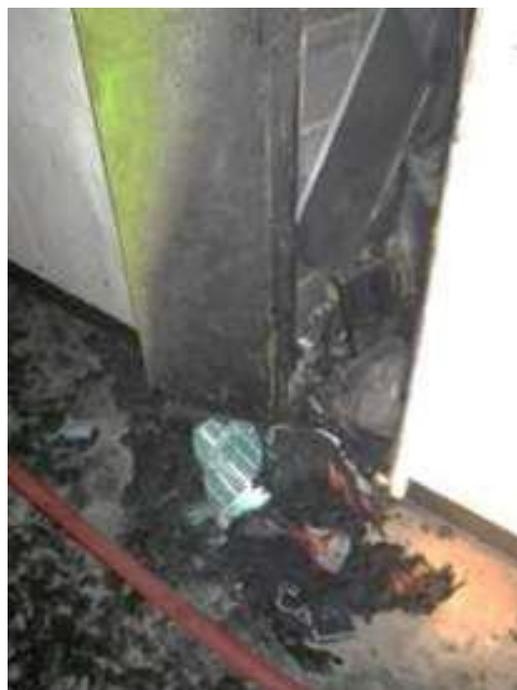
4.9 The image to the right shows the cupboard with some fire debris removed. There was not a huge amount of material involved, considering the extensive smoke damage, as seen in the image below.

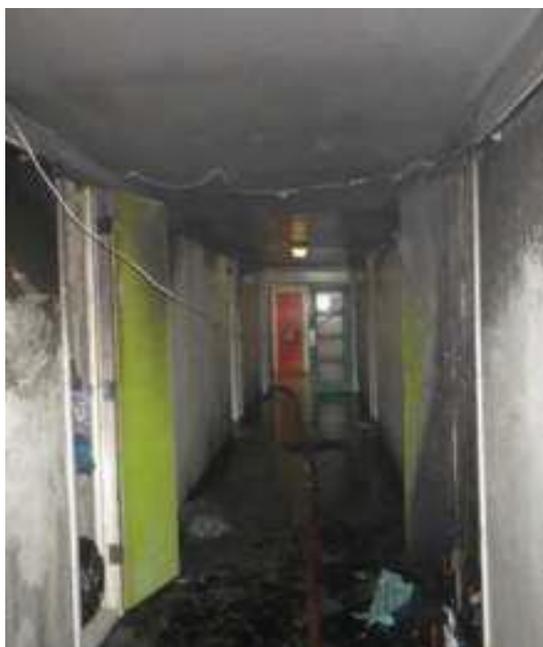
4.11 The fire was confined to the area of origin with the remainder of the lobby and corridor being damaged by heat and smoke.

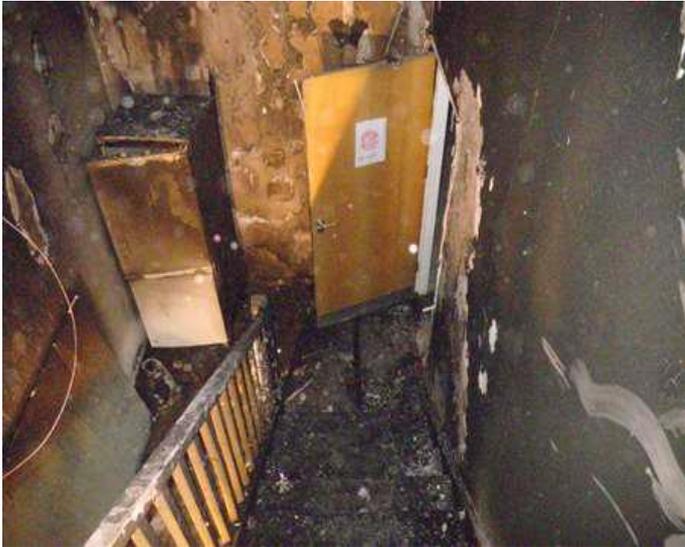
4.14 Fuelled by paper and stored goods, the fire started in the hallway on the ground floor offices at the base of the internal staircase to the flats (as shown in image to the left) and damaged approximately 50% of the ground floor. The remainder of the ground floor was damaged by heat and smoke, with the rest of the building damaged by smoke.

Note: There is an increased risk associated with having building work being carried out in occupied buildings. Everyone should be extra-vigilant. Proper consideration of the risks and appropriate implementation of protective measures should be applied.

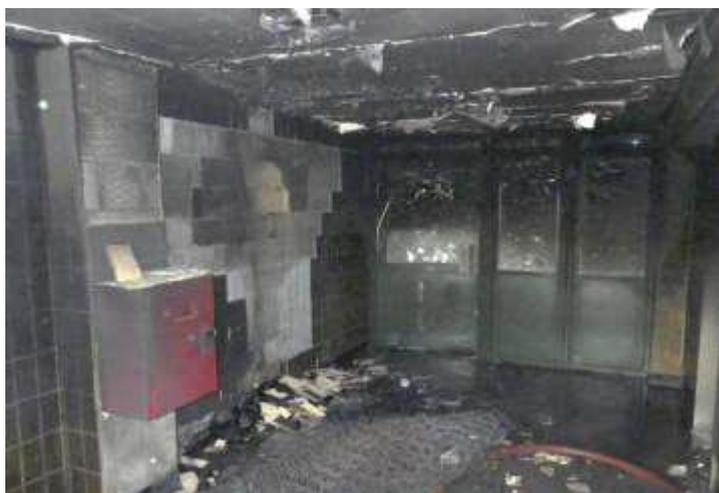
- 4.18 This fire occurred in the 6th floor communal area of a residential block of 10 floors. The deliberate fire involved two separate areas of fire, a mattress in the lift lobby and an upholstered chair in the adjacent stairwell within the same fire fighting shaft.
- 4.19 There was very little lateral smoke spread, however there was considerable smoke damage to the stairway between the 6th floor and the 10th (top) floor. Six fire engines and a turntable ladder attended.
- 4.20 A 30 year old female and a 4 year old child were trapped in a flat at 6th floor level and received fire survival guidance. Both were rescued by firefighters wearing breathing apparatus and subsequently examined at the scene by the London Ambulance Service and treated for smoke inhalation.

- 4.21 *Image above: View of communal area with the remains of the mattress in foreground. Note damage to ceiling and walls, doors and wall panels.*
- 4.22 *Image below: View from other side of doors. Note extensive damage to ceiling, walls, doors and wall panels. Light fitting and electrical wiring indicated by red arrow also damaged by fire.*

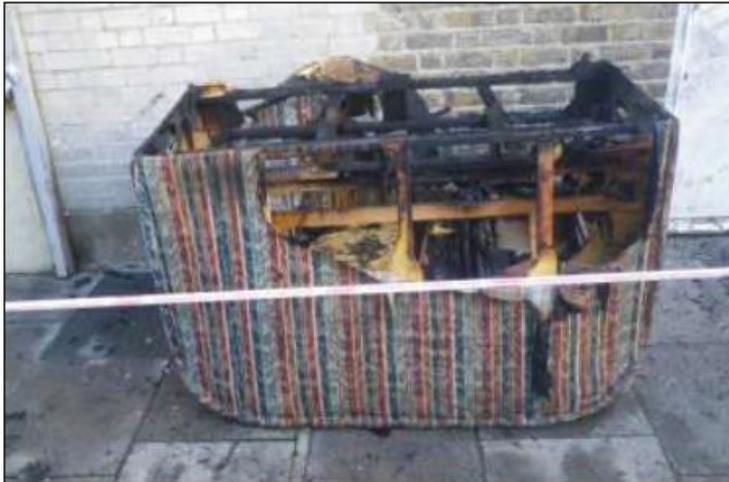
4.24 The fire is believed to be caused by the careless disposal of smoking materials into paper (envelopes magazines and cardboard) which were on top of an abandoned two seat sofa in the communal area of the ground floor stairwell (image below), the sofa was only partially damaged, however:

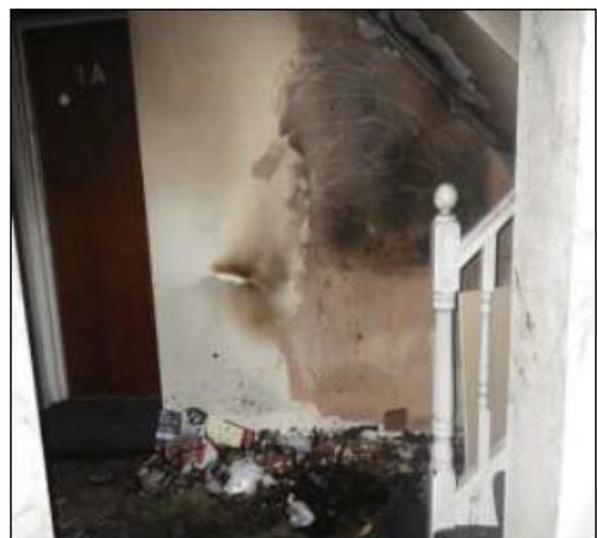
4.26 The image (to right) shows the area of origin where the sofa was. Note that the structural damage was not particularly severe in this case, but the smoke travel resulted in the rescues and injuries detailed above.

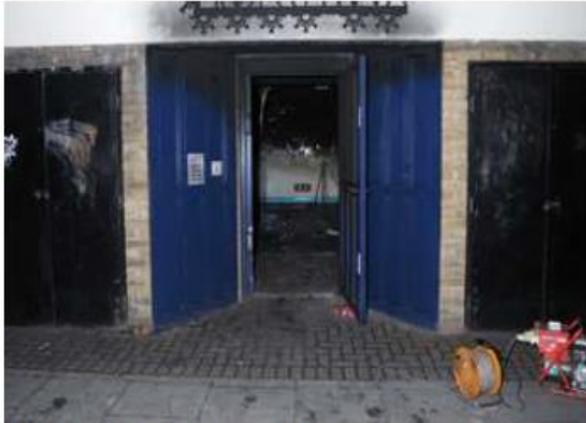
View of front communal entrance

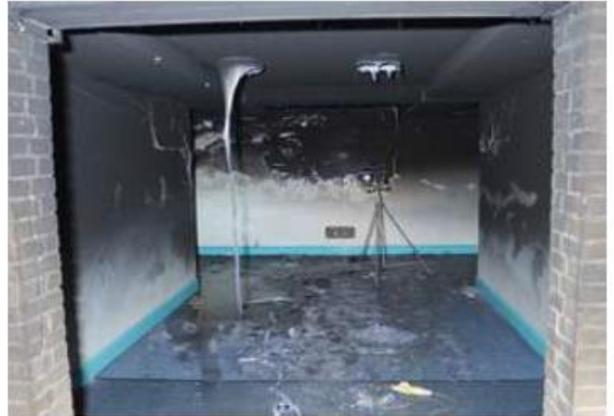
View going in through the communal entrance. Note light fittings have melted

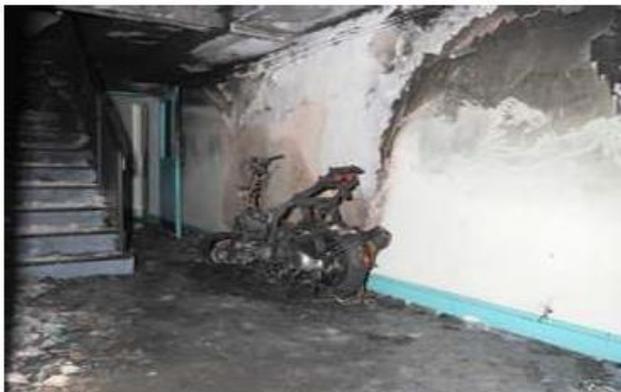
Clear burn pattern behind the scooter, Note rear tyre is still intact

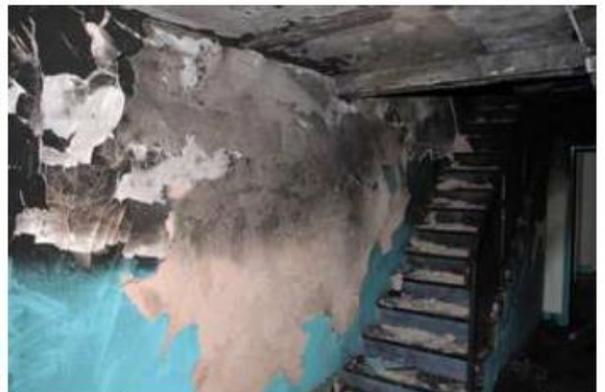
Stairwell opposite the scooter. Note; spalled plaster from the stairwell has fallen onto the stairs

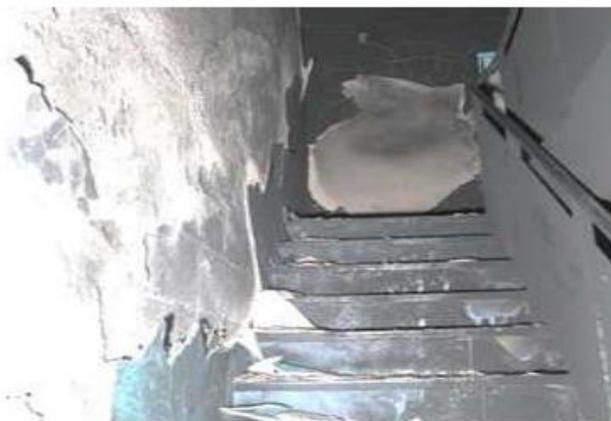
Image to left: View upstairs showing extensive heat and smoke damage.
