LONDON FIRE BRIGADE

FIRE SAFETY GUIDANCE NOTE

Fires in Communal Areas - Information for External Partners

Number:
GN84

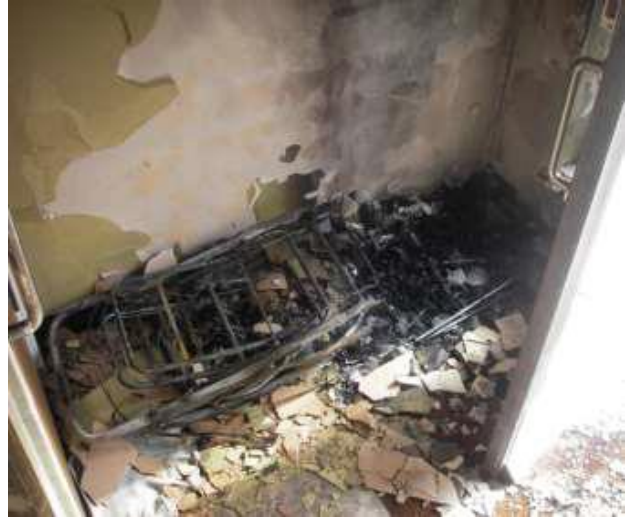
Example 1 – Small buggy set alight in an entrance lobby of a modern low rise block of flats.

4.1 The image to the right shows a small buggy which was set alight in a very modern entrance area to a low rise block served by a single staircase and entrance. There was apparently very little additional fuel loading e.g. no toys and extra blankets.

4.2 The damage to the ceiling, plaster work, décor and electrics in the area would have resulted in a significant repair cost. It was lucky that no one came out of their flats during the fire, as there would have been significant amounts of toxic smoke and hot fire gases.

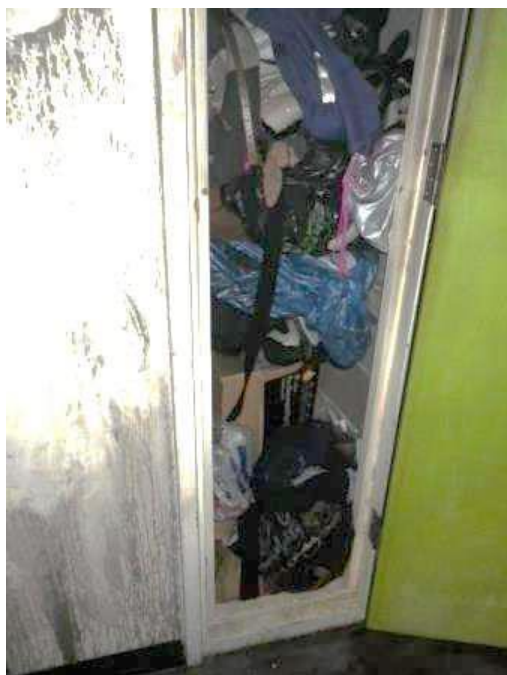
Example 2 – Small cupboard in internal hallway in a high rise block of flats. Domestic items belonging to one of the residents were stored in it.

4.6 The three images on this page relate to a fire which occurred in a common lobby shared by 4 flats on the second floor of a high rise block. The seat of the fire was within a small cupboard (approximately 30-50cm wide) used to house services such as drainage and telephone cables. The cupboard had been filled with old clothes and electrical items (example image left).

Note: Risers in common areas should be kept locked shut to prevent inappropriate storage in these areas. This should be part of ongoing management / maintenance of the building.

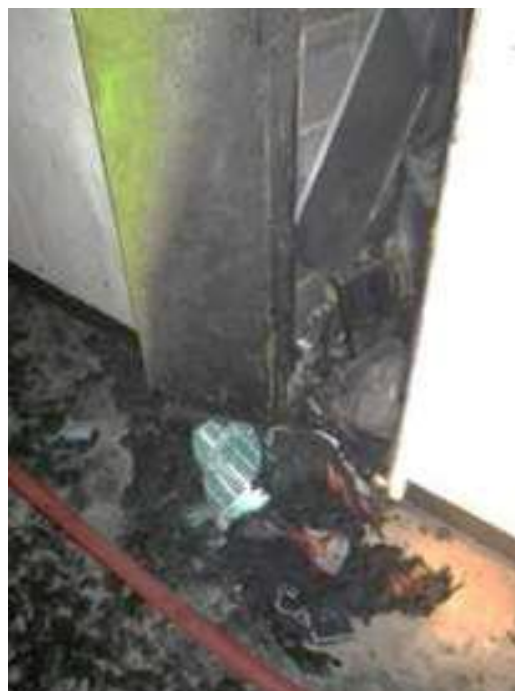
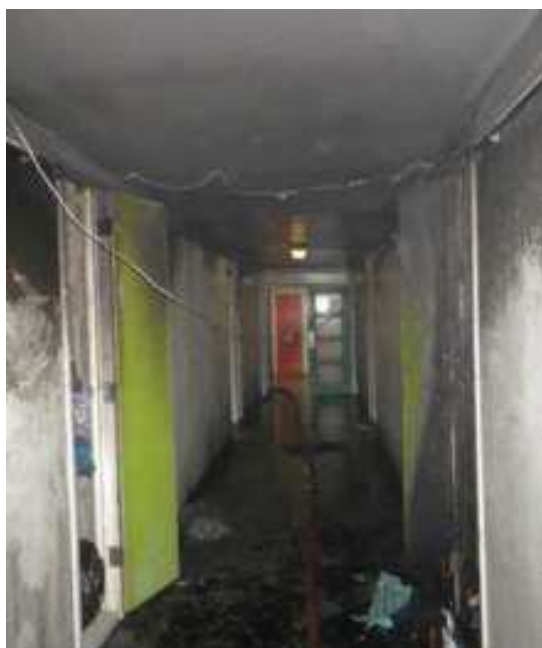
4.9 The image to the right shows the cupboard with some fire debris removed. There was not a huge amount of material involved, considering the extensive smoke damage, as seen in the image below.

4.11 The fire was confined to the area of origin with the remainder of the lobby and corridor being damaged by heat and smoke.

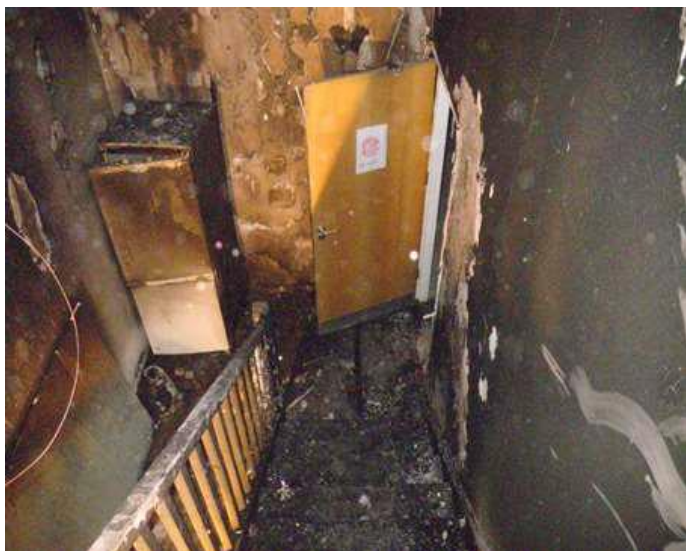
Example 3 – Papers & stored goods in a mixed use semi-detached building of three floors.

4.14 Fuelled by paper and stored goods, the fire started in the hallway on the ground floor offices at the base of the internal staircase to the flats (as shown in image to the left) and damaged approximately 50% of the ground floor. The remainder of the ground floor was damaged by heat and smoke, with the rest of the building damaged by smoke.

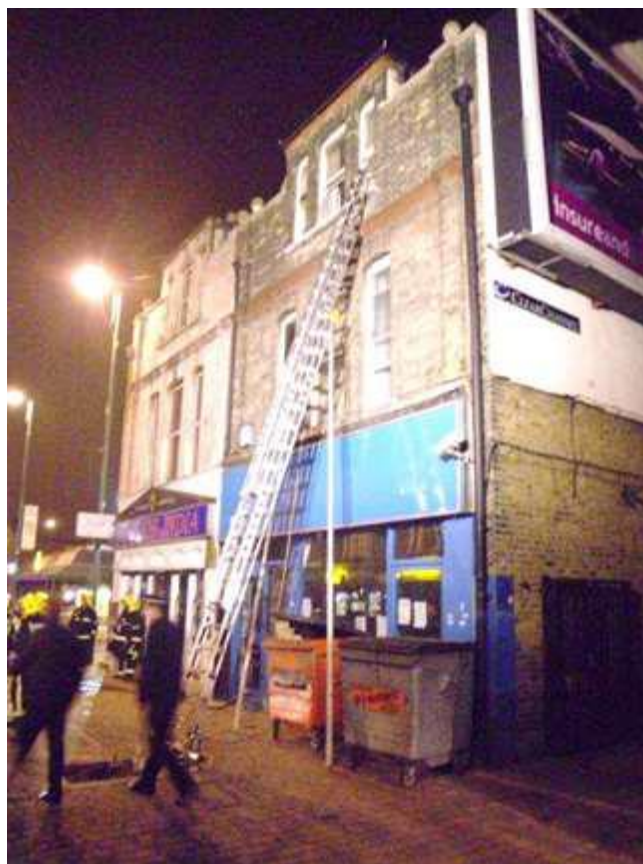
- 4.17 All seven occupants had to be rehoused. The cause of the fire was believed to be deliberate.

Note: There is an increased risk associated with having building work being carried out in occupied buildings. Everyone should be extra-vigilant. Proper consideration of the risks and appropriate implementation of protective measures should be applied.

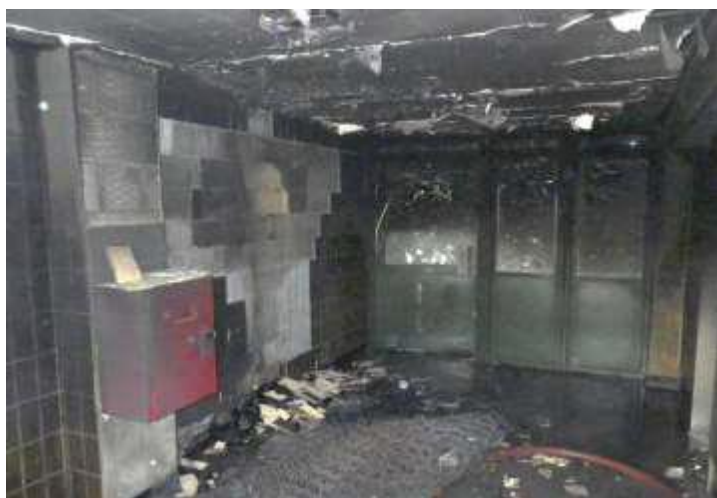
- 4.21 *Image above: View of communal area with the remains of the mattress in foreground. Note damage to ceiling and walls, doors and wall panels.*
- 4.22 *Image below: View from other side of doors. Note extensive damage to ceiling, walls, doors and wall panels. Light fitting and electrical wiring indicated by red arrow also damaged by fire.*

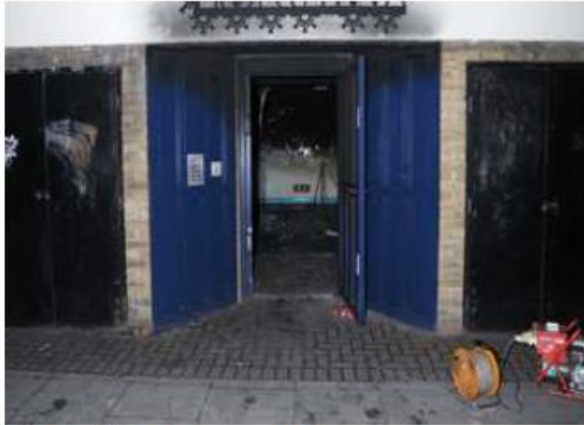
4.27 The following example involved a small motor scooter in a communal area. What is notable is the extensive damage not only from smoke, but also from the heat. There was apparently relatively little petrol in the scooter; the majority of the fuel loading was from the plastic body panelling.

View of front communal entrance

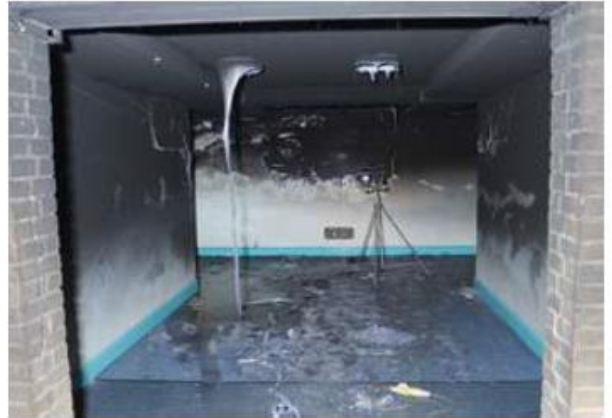
View going in through the communal entrance. Note light fittings have melted

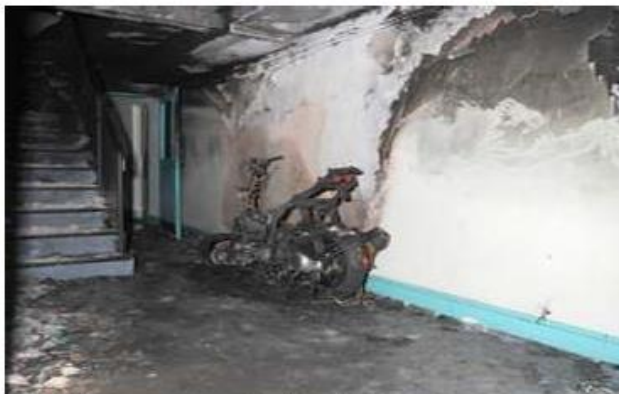
Clear burn pattern behind the scooter, Note rear tyre is still intact

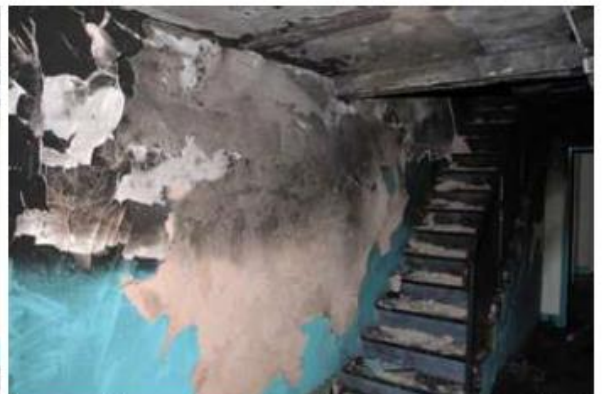
Stairwell opposite the scooter. Note; spalled plaster from the stairwell has fallen onto the stairs

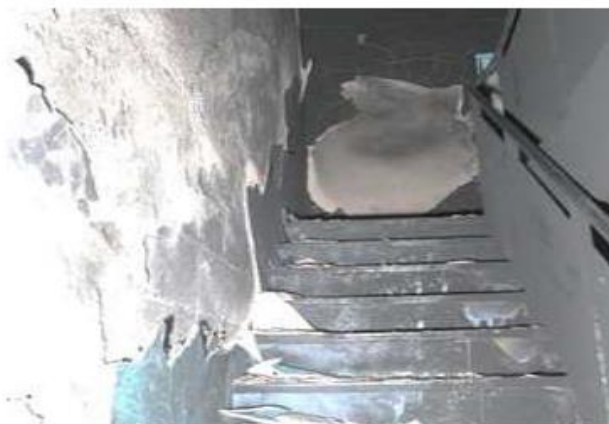
Image to left: View upstairs showing extensive heat and smoke damage.
