Fire Report

**15 Pump Major Incident
21 The Green,
Wennington,
RM13 9DX
Borough of Havering**

Date of Incident: 19 July 2022

Fire Investigation Team Report

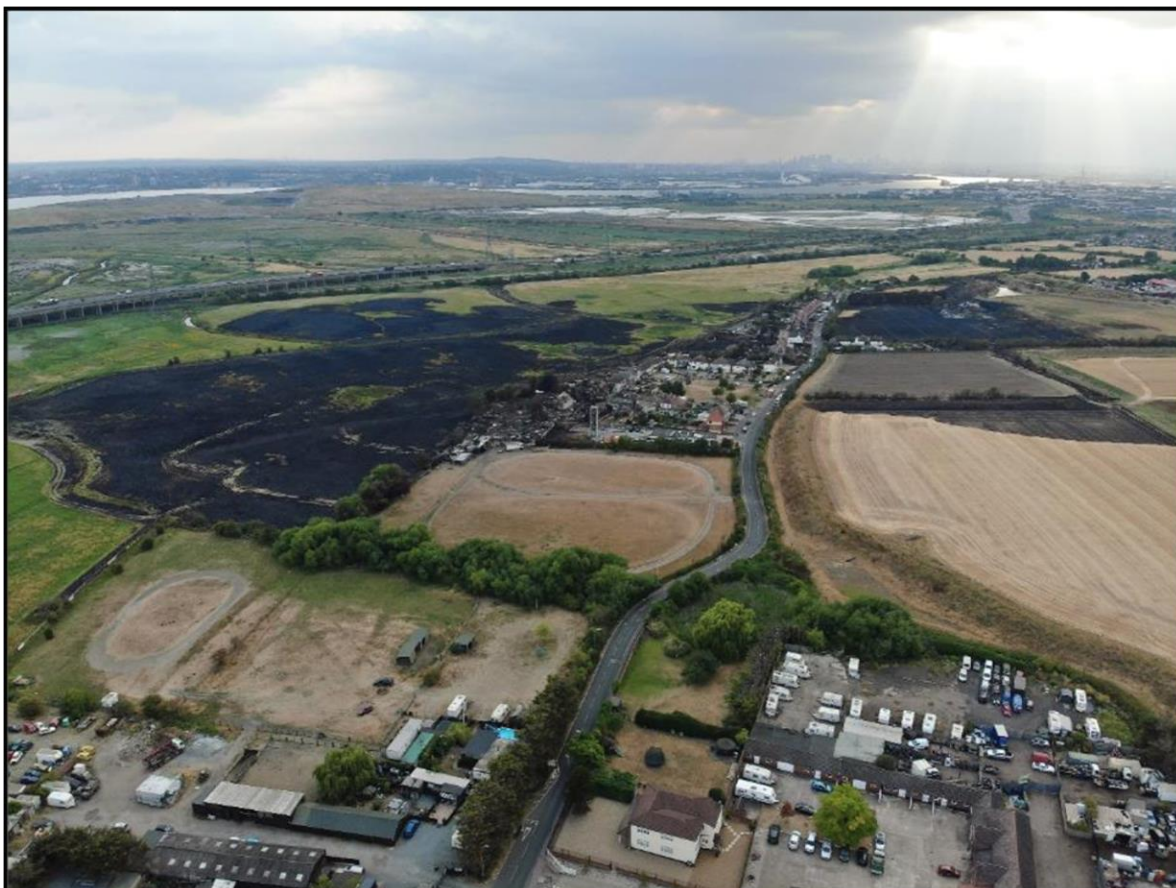
The fire scene incorporated an area of approximately 40 hectares. Within that area was marshland, farmland and Wennington village.

Aerial view of fire damage
(looking east to west)

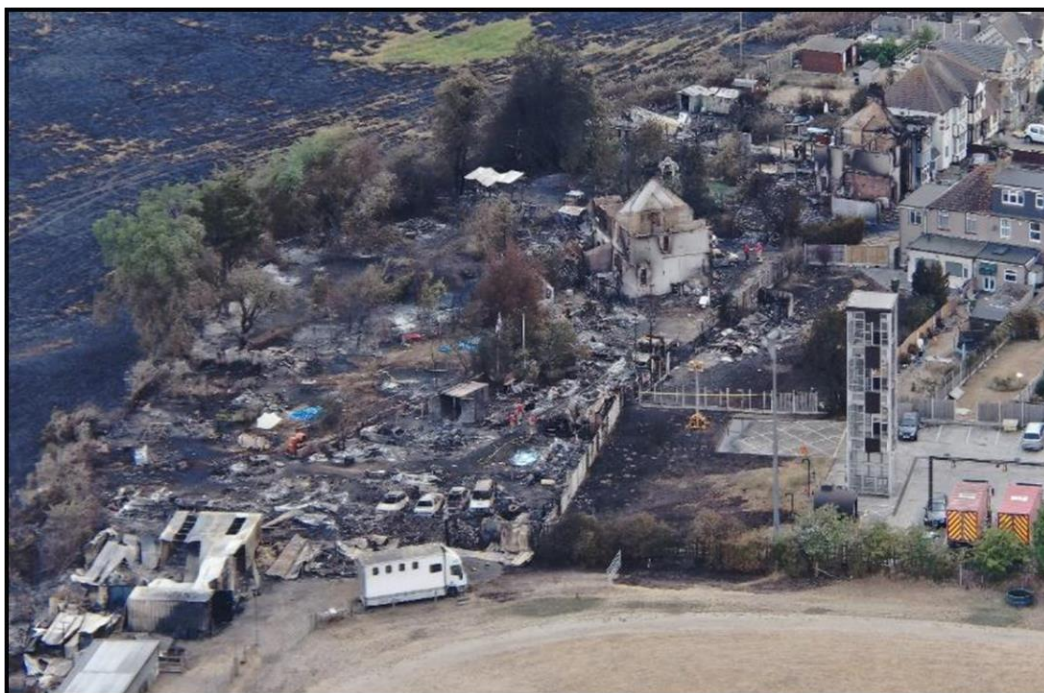
- 9.3 Taking into account the wind direction (south-south-easterly) it is possible that the fire originated in the marshland to the rear of the gardens, spreading into the garden, where it was first seen. Satellite imagery shows a footpath has been worn across the marshland and runs close to the garden of No.21. It is possible that either; a fire has been started deliberately that hasn't initially taken hold, but has smouldered for a short time, or a cigarette (or other ignition source) has been discarded, initiating a smouldering fire which has then transitioned to a flaming fire.

Image 1:
Overview of area of origin

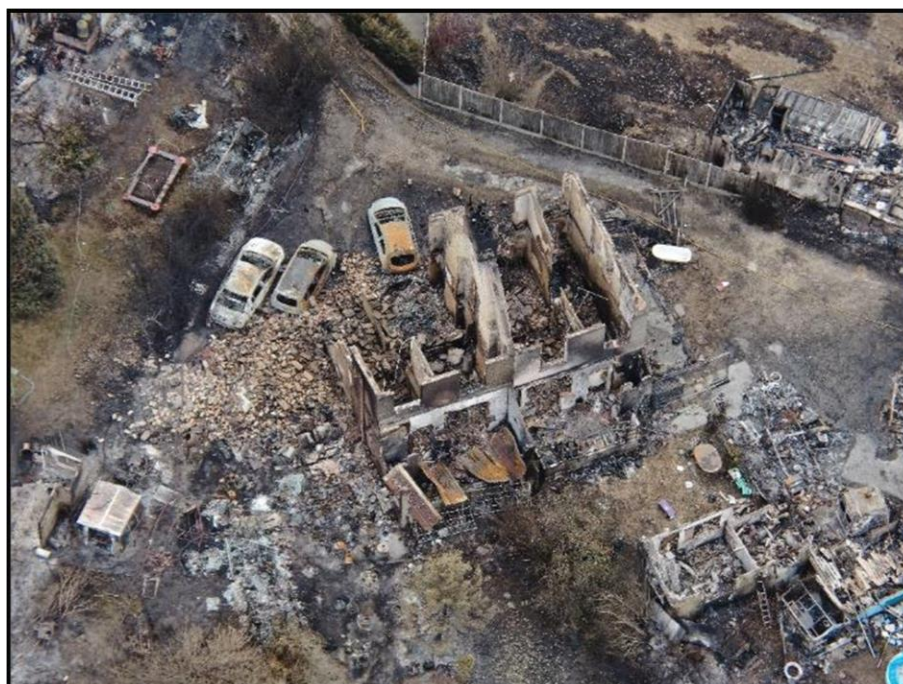
- 7.7 As a result of the wind direction No's.21 and 22 were 100% damaged by fire.
- 7.8 The wind continued to spread the fire into No's.19 and 20 which were both 100% damaged by fire. Firefighters managed to prevent the fire from spreading any further within The Green.

Image 2:
No's.21 and 22 The Green – viewed from the south

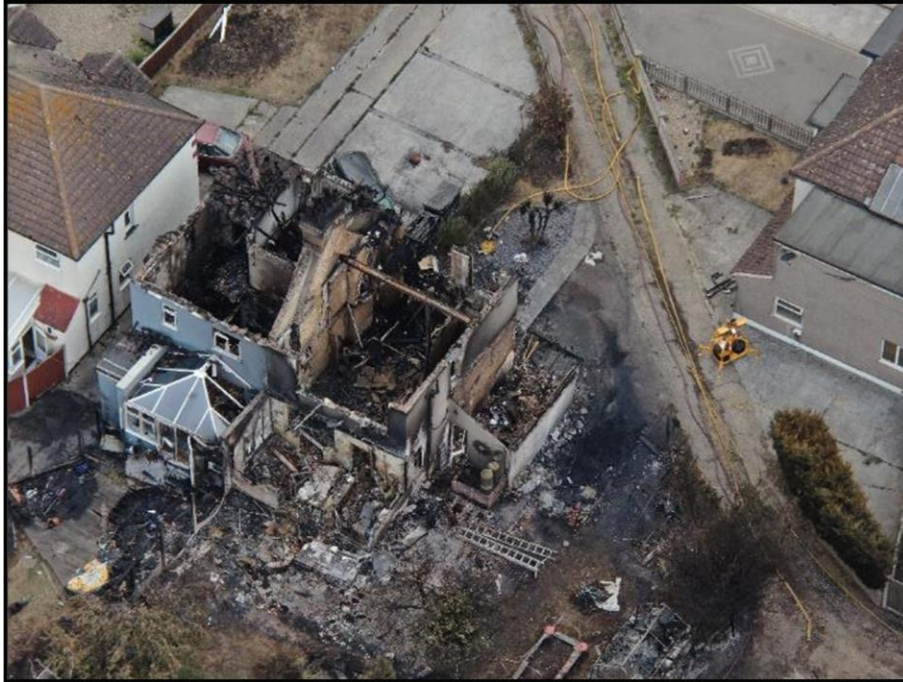
Image 3:
No's.19 and 20 – viewed from the south

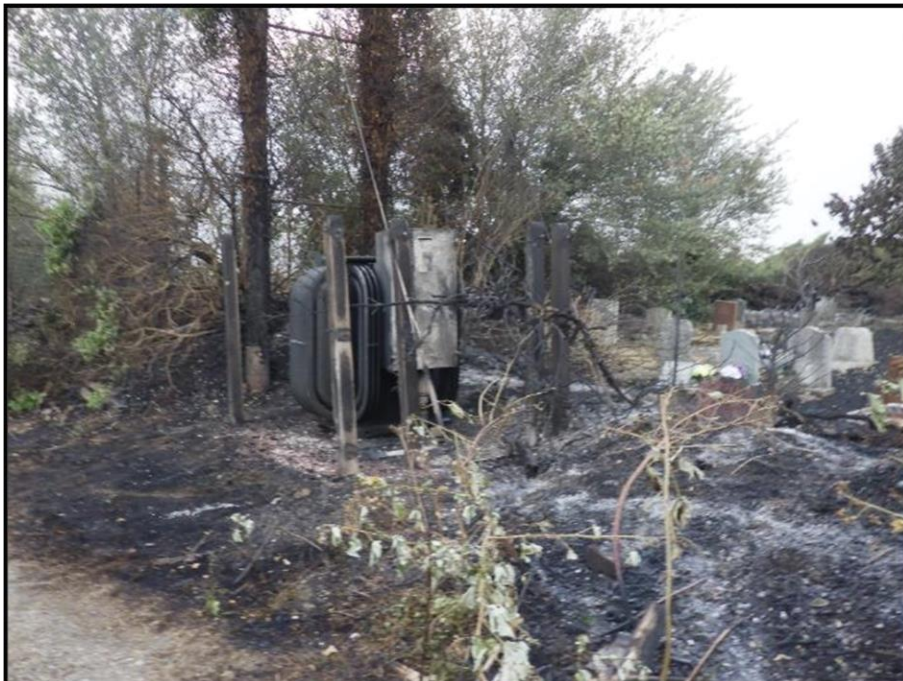
- 7.13 Approximately halfway down the track on the right-hand side was an electrical substation, this was 100% damaged by fire.
- 7.14 To the rear of the churchyard was an area of wasteland, the fire had spread across this and encroached upon a row of domestic garages that were associated with Kent View. The first four garages and the furthest garage were all damaged by fire.

Image 4:
Electrical substation – near to Church

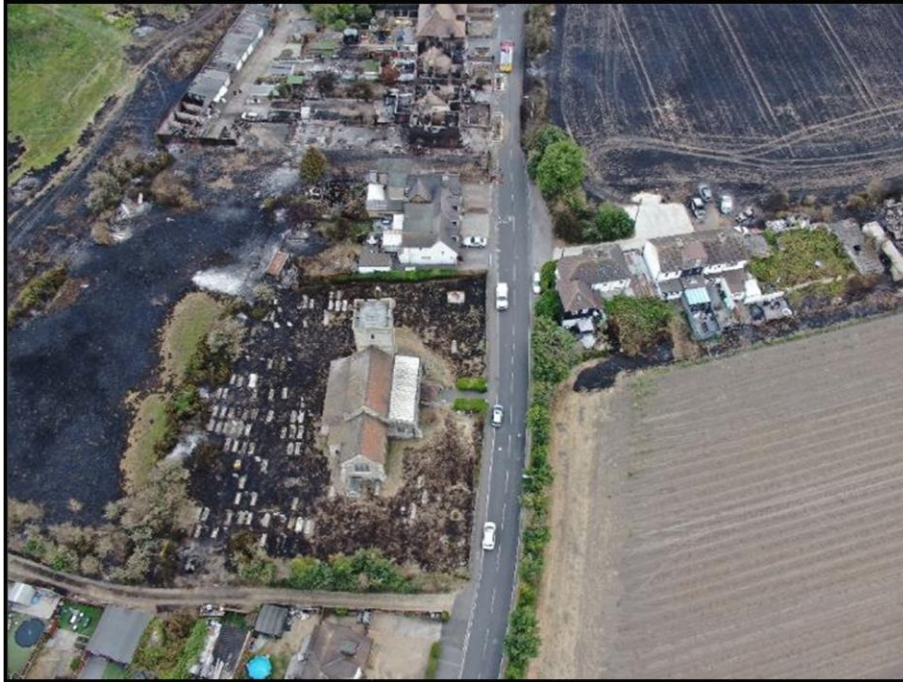
Image 5:
Fire spread around Church

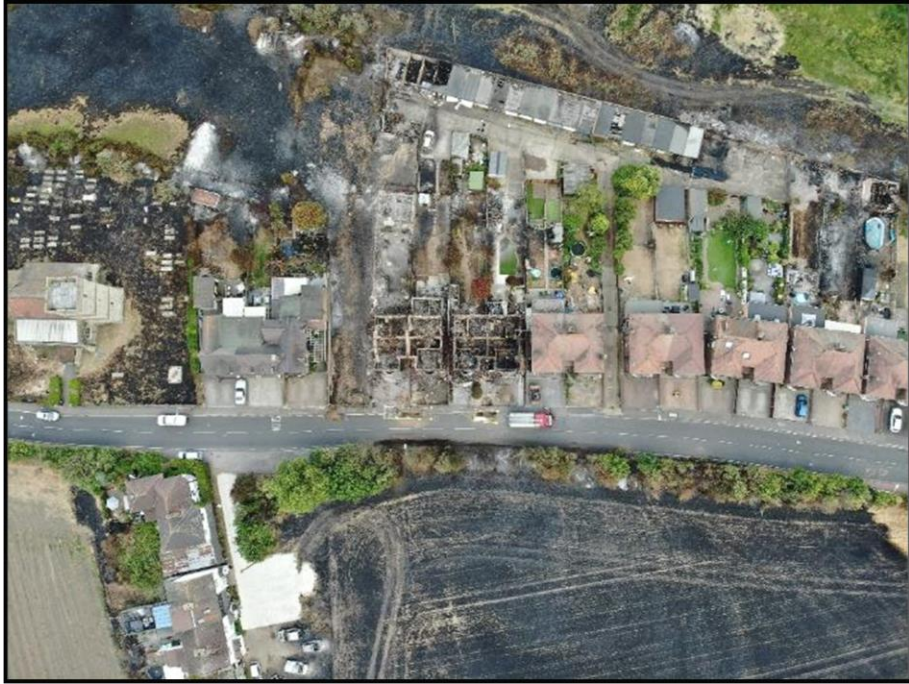
- 7.15 The wind pushed the fire into the rear gardens of Kent View, which contained various sheds and outbuildings, and into No's.17, 18, 19 and 20 which were two sets of semi-detached properties. The gardens and properties were 100% damaged by fire.

Image 7:
Fire spread to Kent View

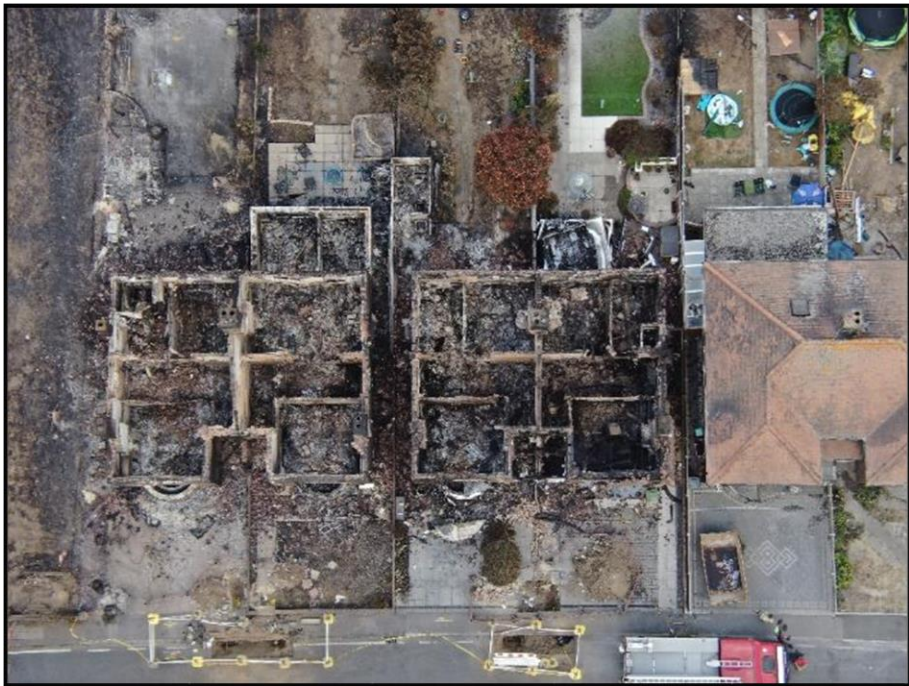
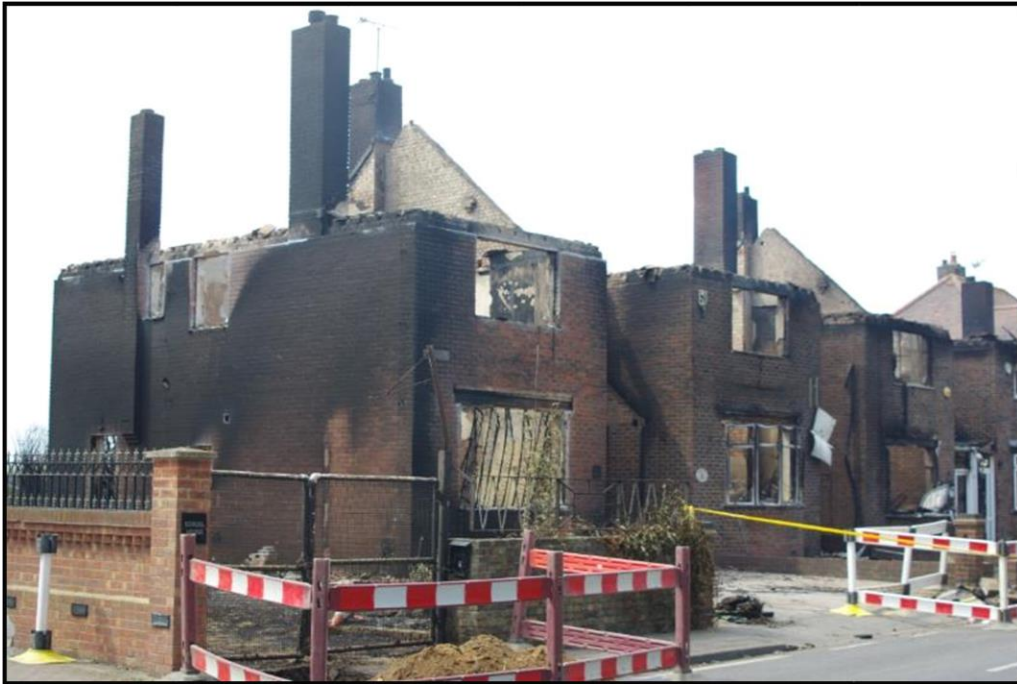
Image 8
No's.17, 18 & 19, 20 Kent View

Image 9:
No's.17, 18 & 19, 20 Kent View

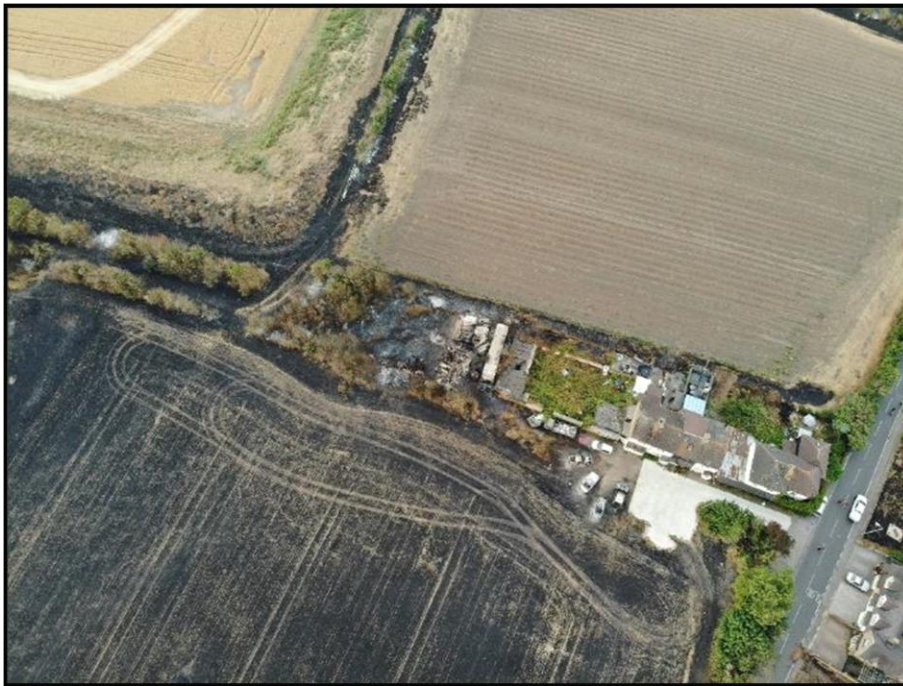
- 7.20 On the north side of Wennington Road, just before Kent View was Church Lane Cottages. This was a small terrace of five properties, a number of outbuildings and a disused storage yard. Four vehicles parked in the lane had been damaged by fire, along with the outbuildings and disused storage yard. The five properties did not sustain any fire damage. In the field to the front of the properties were a number of cylinders, these had been removed from the hedgerow near to the disused storage yard.

Image 10:
Church Lane Cottages

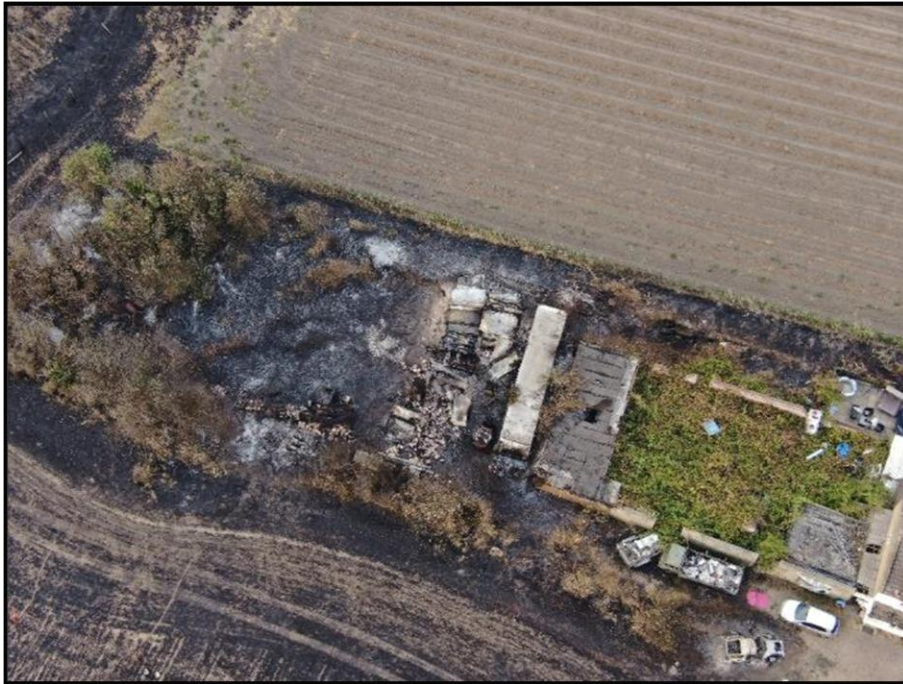
Image 11:
Disused yard – Church Lane Cottages

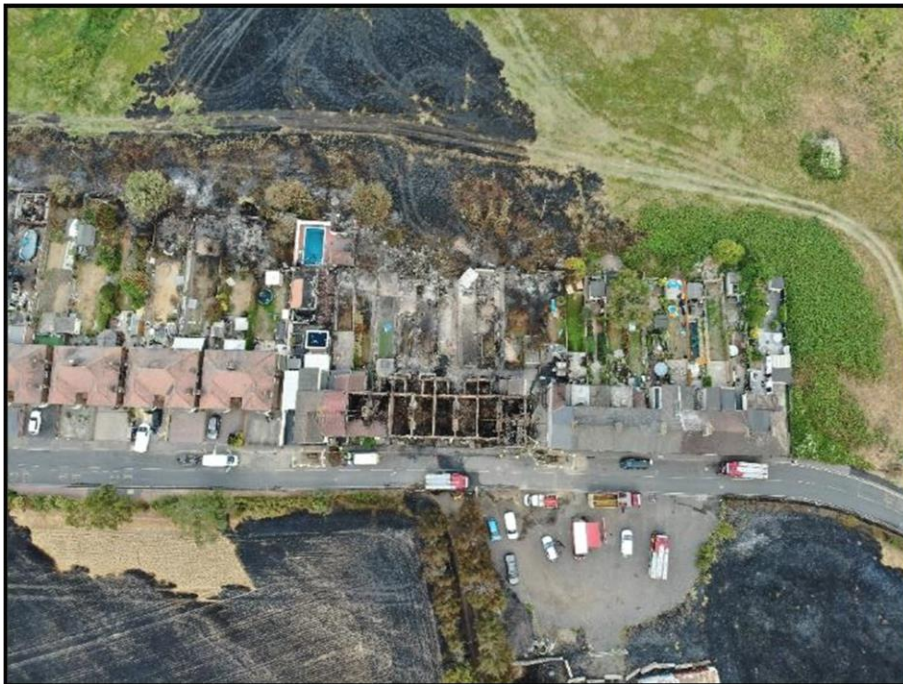
- 7.17 The wind continued to drive the fire across the marshland, where it again re-entered the gardens at Marine cottages which contained various sheds and outbuildings. The fire spread up the gardens and into the properties, which consisted of a terrace of 10 properties. No's.3 to 10 were 100% damaged by fire.

Image 12:
Fire spread – Marine Cottages

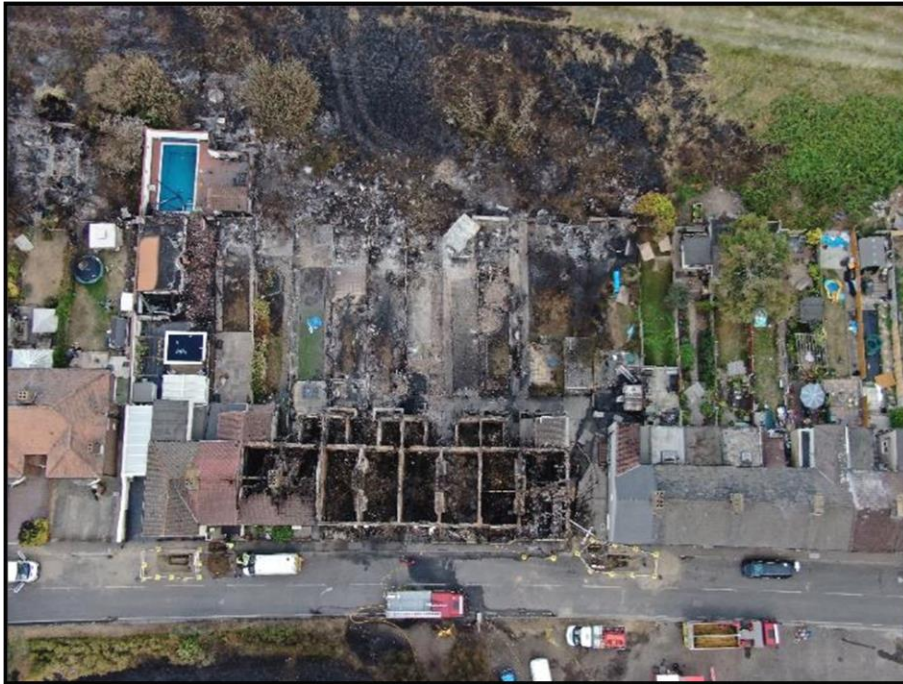
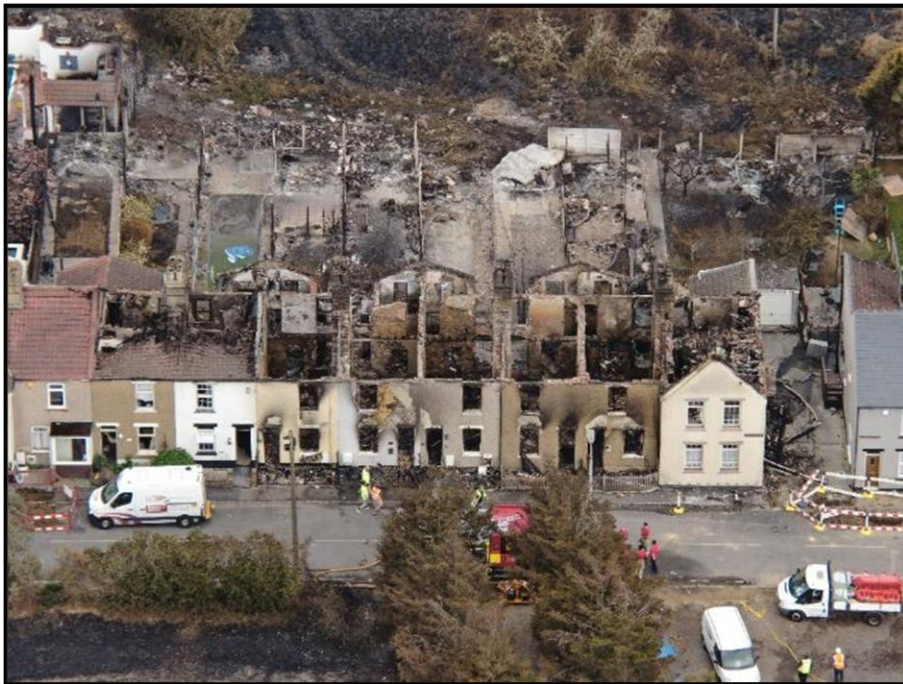
Image 13:
Marine Cottages

Image 14:
No's 3 to 10 Marine Cottages

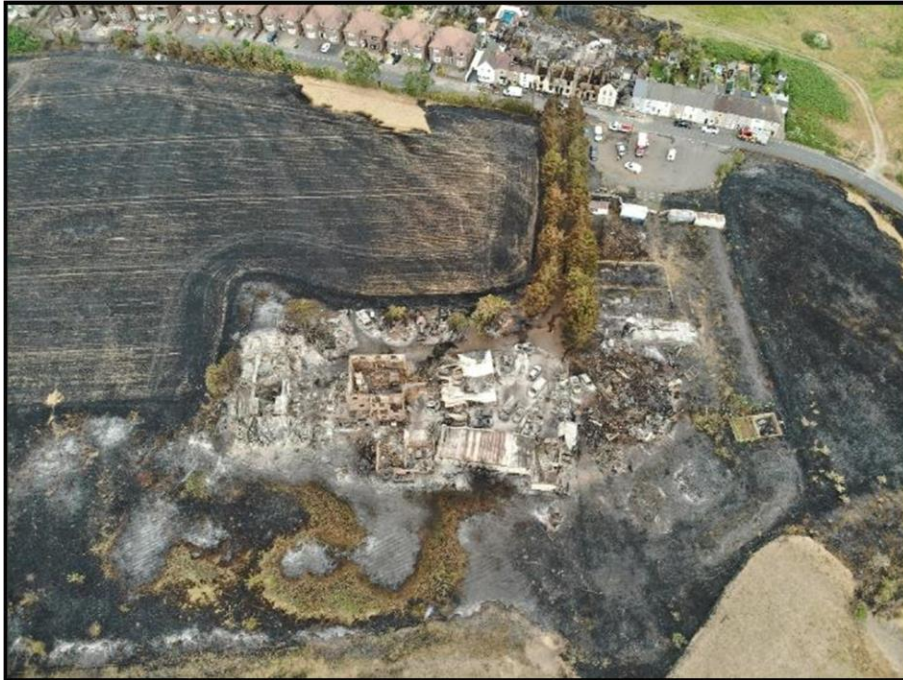
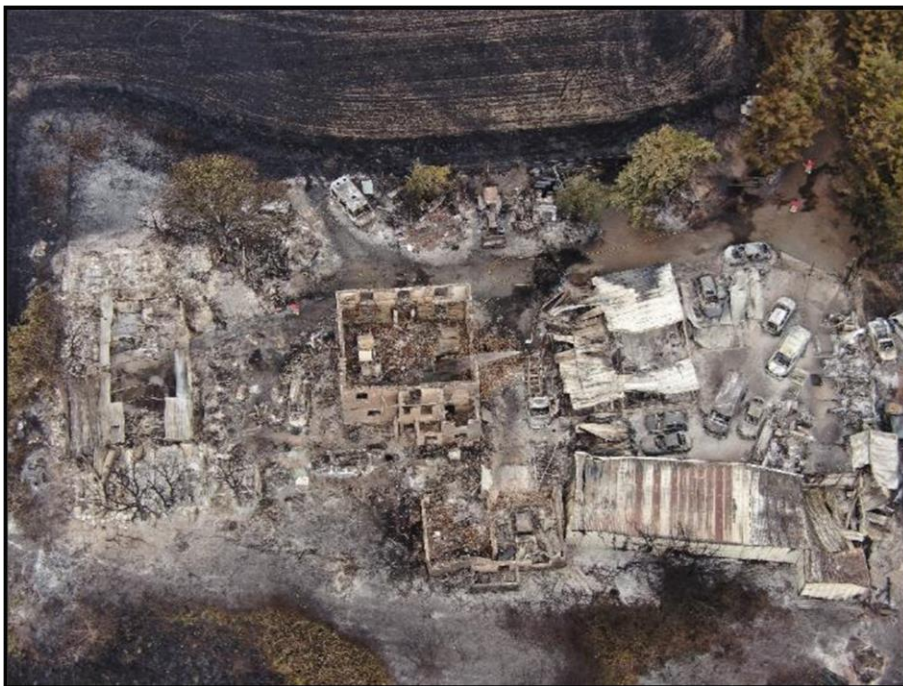
- 7.21 Further along Wennington Road, opposite Marine Cottages was a lane that gave access to Lenthorpe House, a car repair workshop, and a number of other outbuildings, these were all 100% damaged by fire. Within the car repair workshop were a number of hazardous cylinders.

Image 15:
Lenthorpe House and car repair workshop

Image 16:
Lenthorpe House
