West Hampstead Square, Automatic Fire Suppression System Activation Case Study

Date of incident: Tuesday 3 July 2018

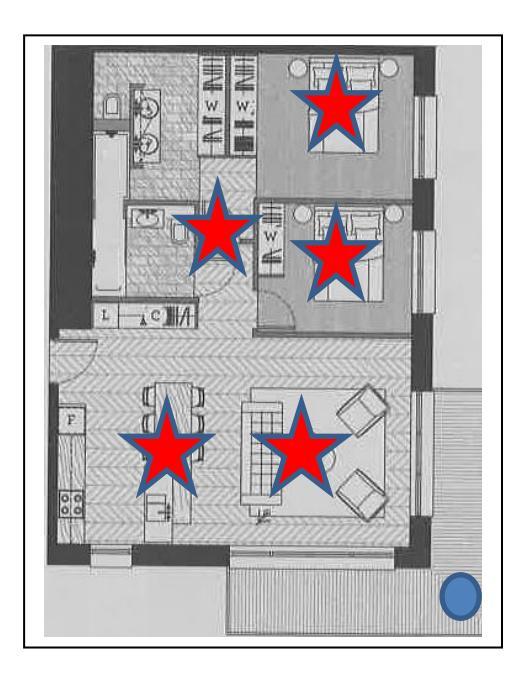
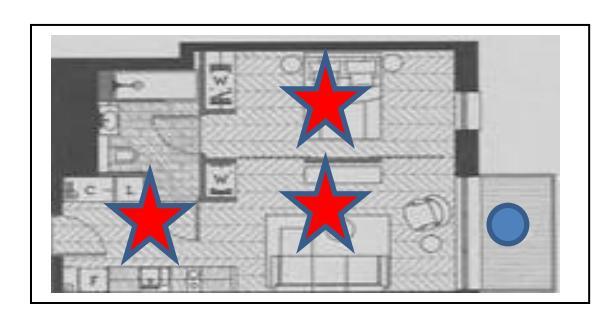
- Seven floors .
- 34 Apartments ranging from studio flats to 1,2 and 3 bedroom apartments.
- Balconies fitted to a selection of apartments.
- Large entrance lobby with 24/7 on site estate management .
- Gymnasium.
- Health spa facilities.
- Access to podium level.
- 3.4 Typical layout of apartment/location nozzle heads, the three bedroom apartments were not involved in the fire.
- 3.5 Dimensions 2 bedroom flat
 - Internal area:- 77.8 sqm
 - Living area:- 7700 x 4500mm
 - Bedroom 1:- 3400 x 3150 mm
 - Bedroom 2:- 2800 X 2790 mm
 - Balcony:- 13.9sqm

- 3.6 Dimensions Suite/Studio
 - Internal area:- 41.4sqm
 - Living area:- 6600 x 3080 mm
 - Bedroom:- 4290 x 2500 mm
 - Balcony:- 3.9sqm

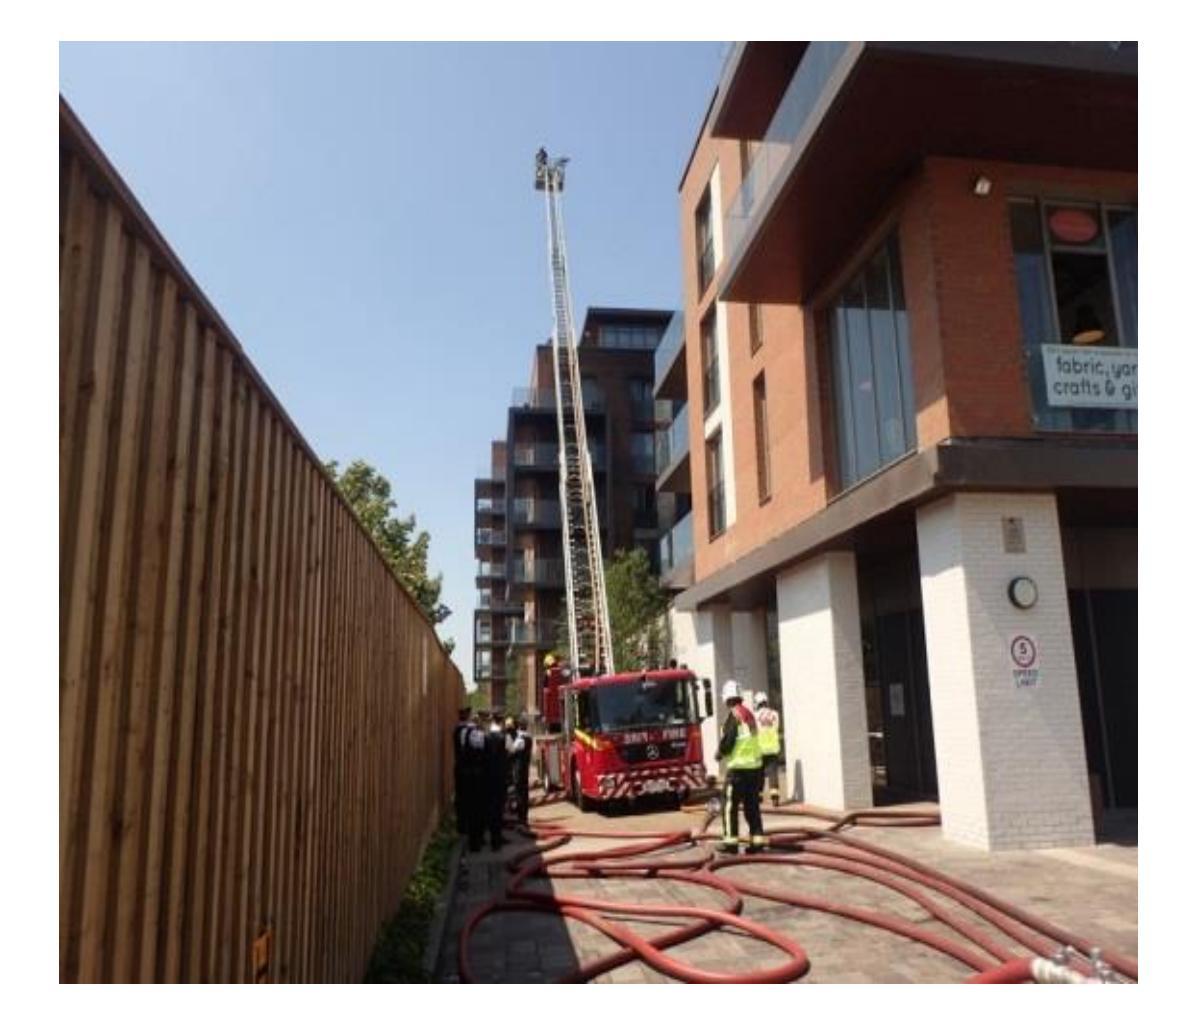
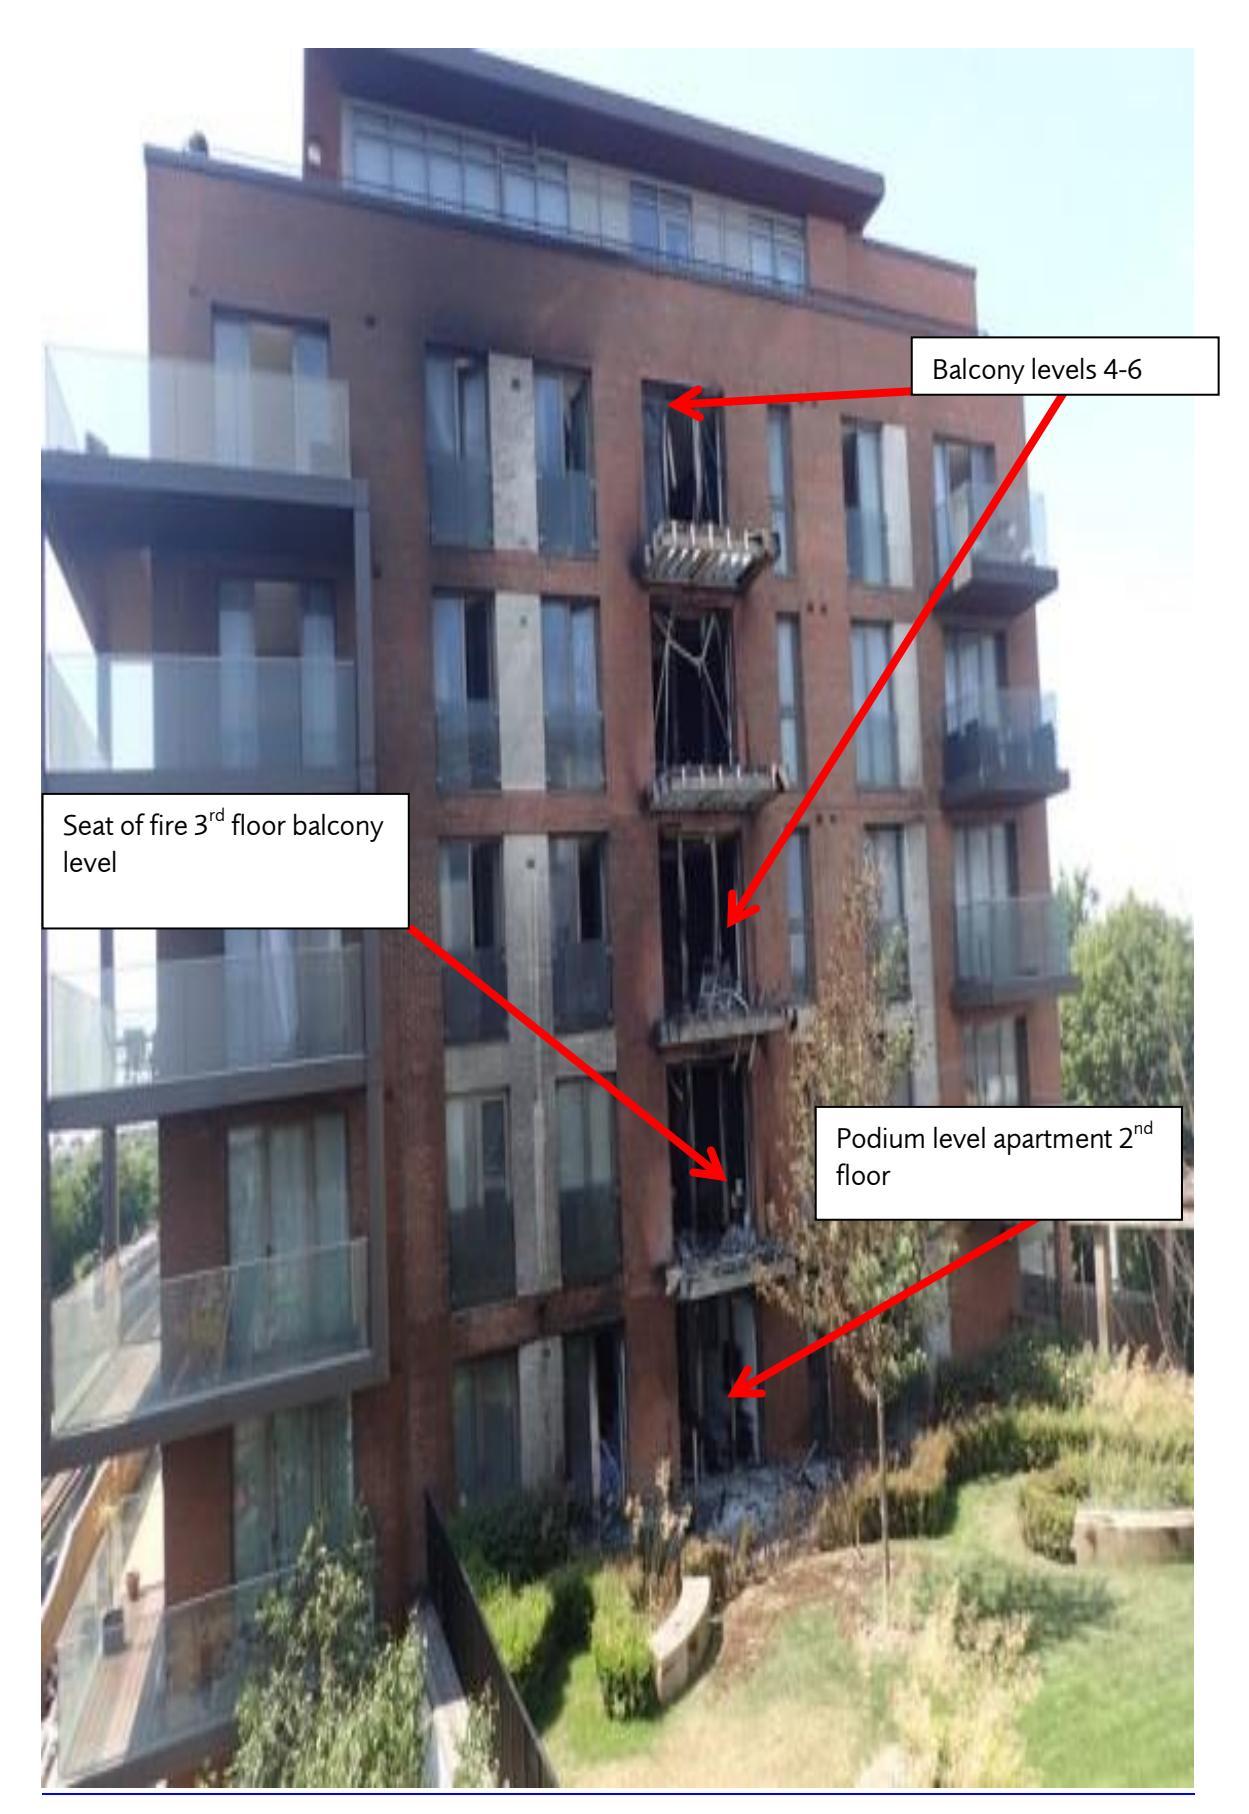
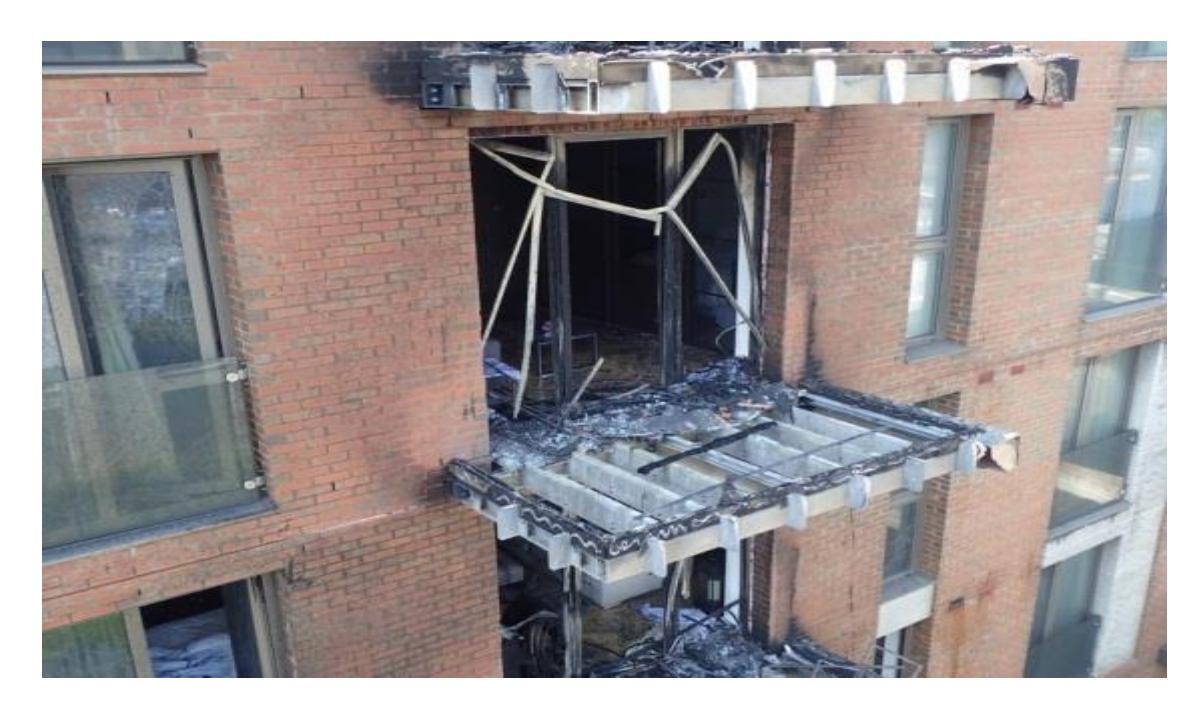
6.6 All four balconies' glazing units were completely destroyed by the fire with only the steel frame remaining, lateral fire spread did not occur and façade was of brickwork construction.

6.7 The windows located either side of the balconies sustained heat and smoke damage. The Podium level apartment sustained fire damage due to fire debris landing on the podium level adjacent to the apartment.

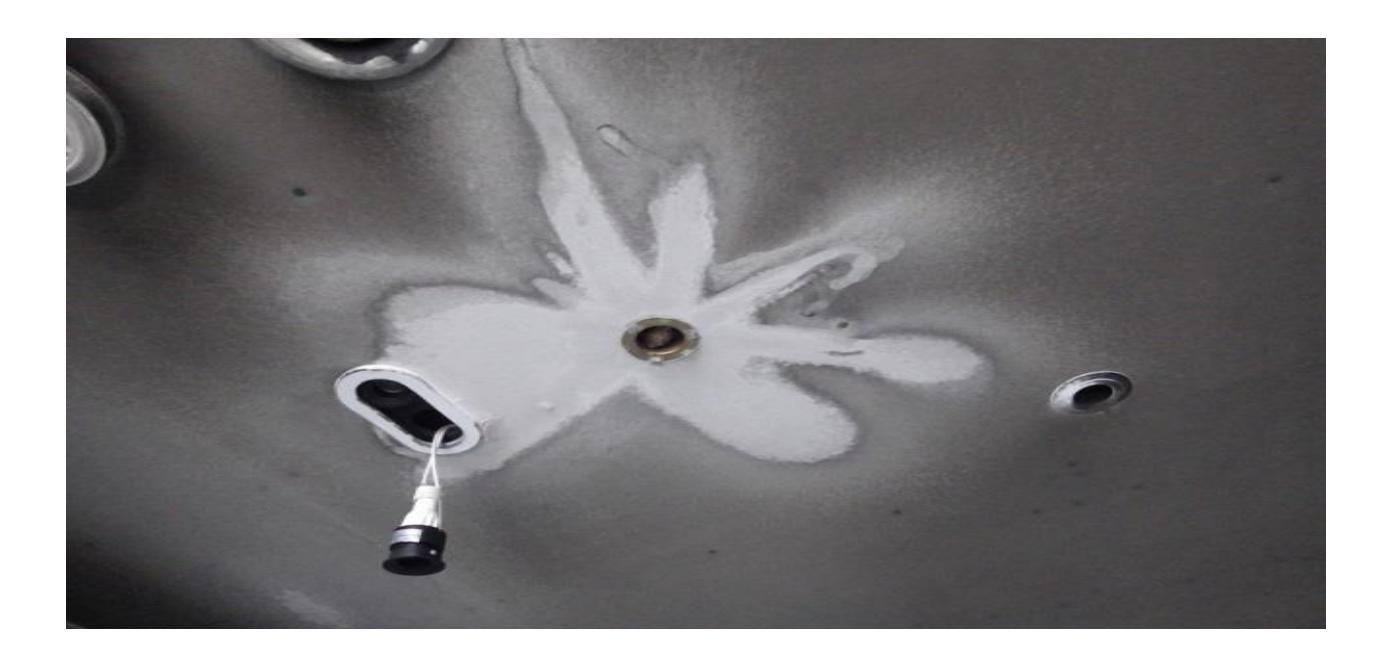
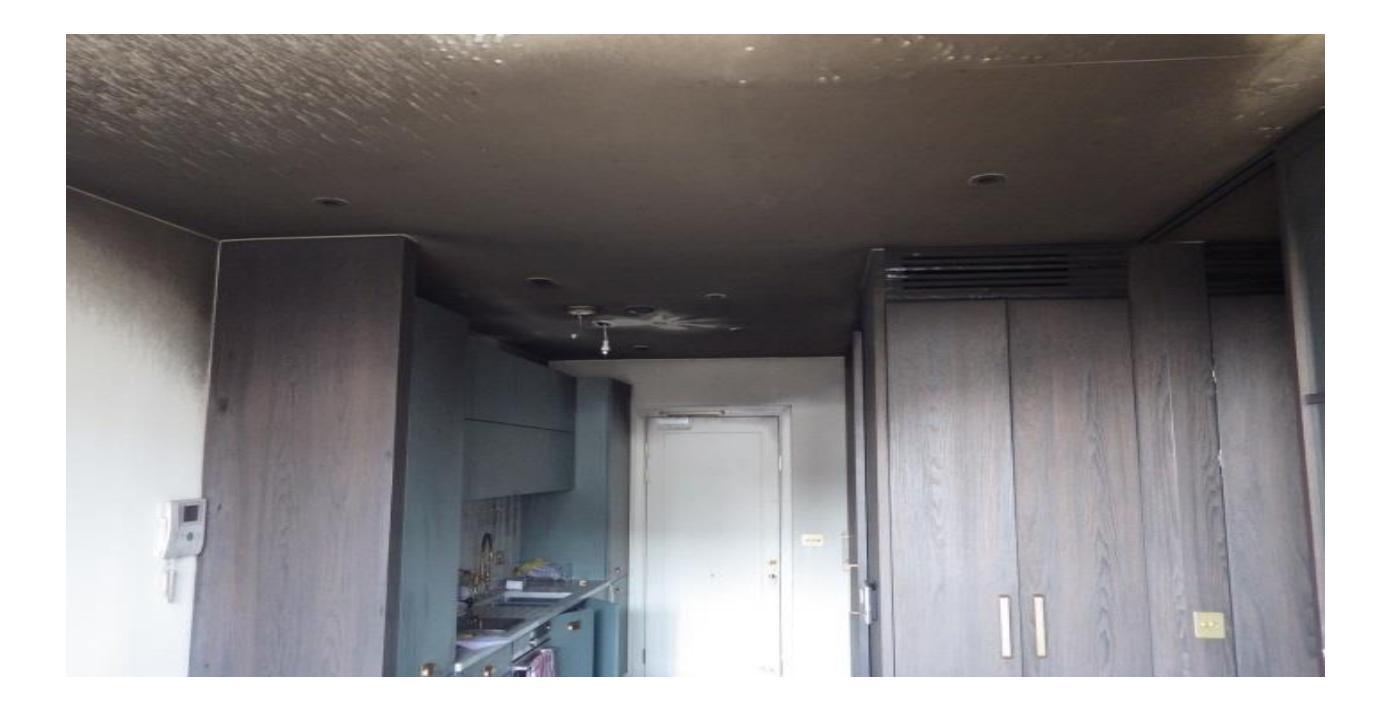
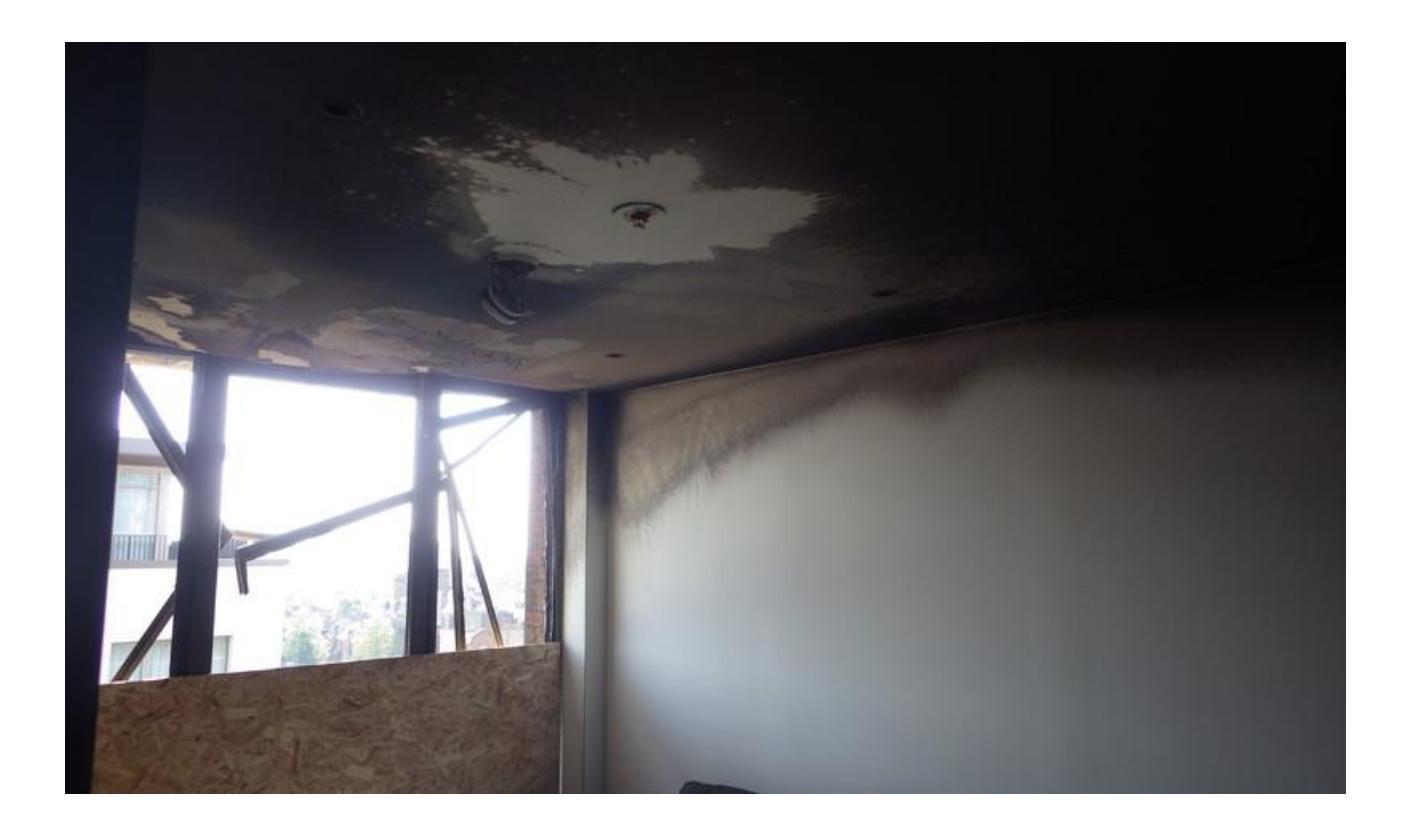
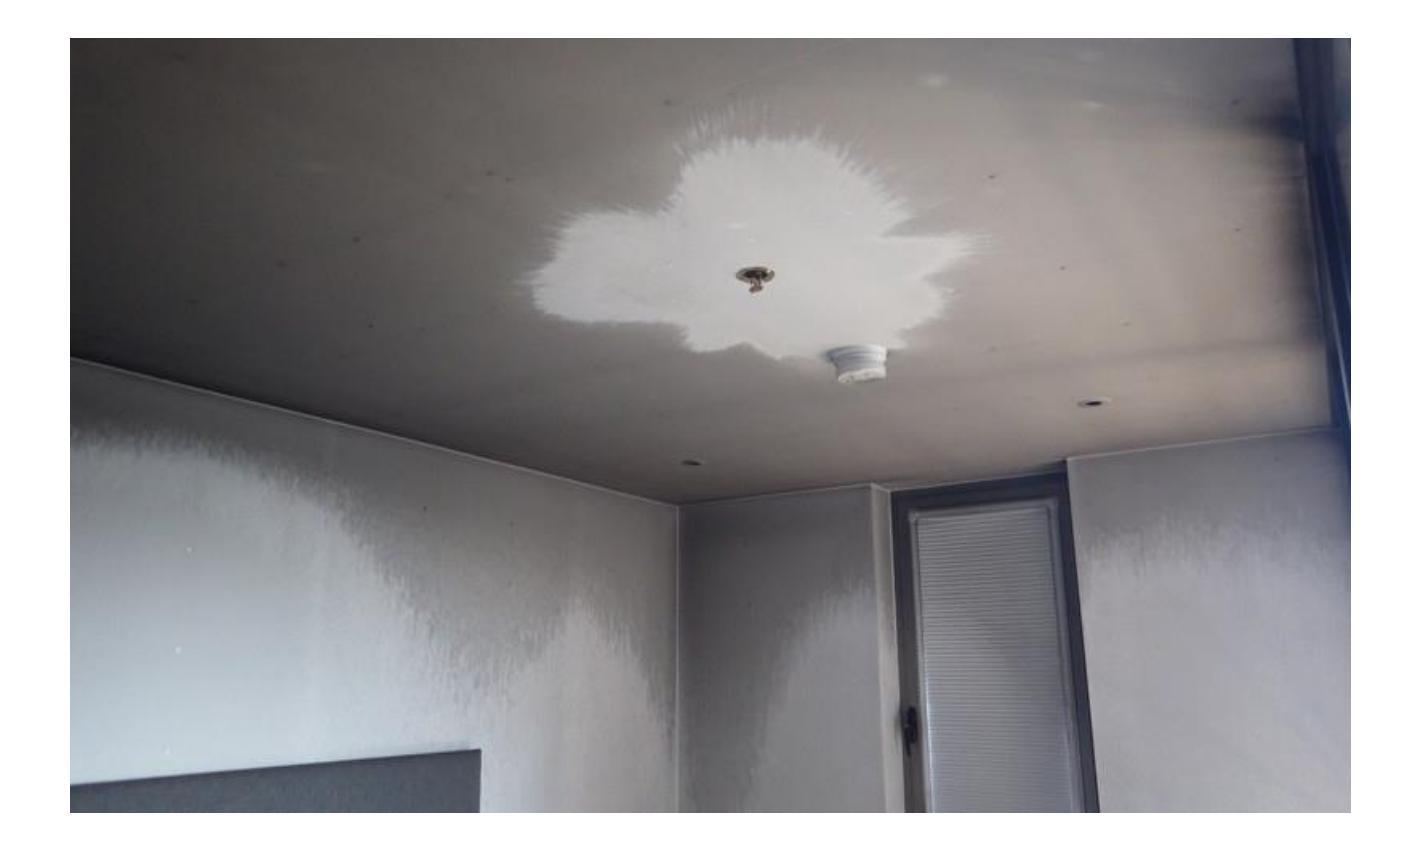
8.3 **11:34 :- 5th Floor level/Room 502 Suite/Studio Flat**, Eight minutes after the time of call, three nozzle heads actuated. The kitchen nozzle head spray coverage was found to have been compromised. It is not conclusive, one logical reason provided by the Residential Sprinkler Association was due to the fact that the nozzle head set was located too high in the ceiling void. If it had been installed another 5-10mm higher the front door and kitchen units would not have been wetted by the nozzle head.

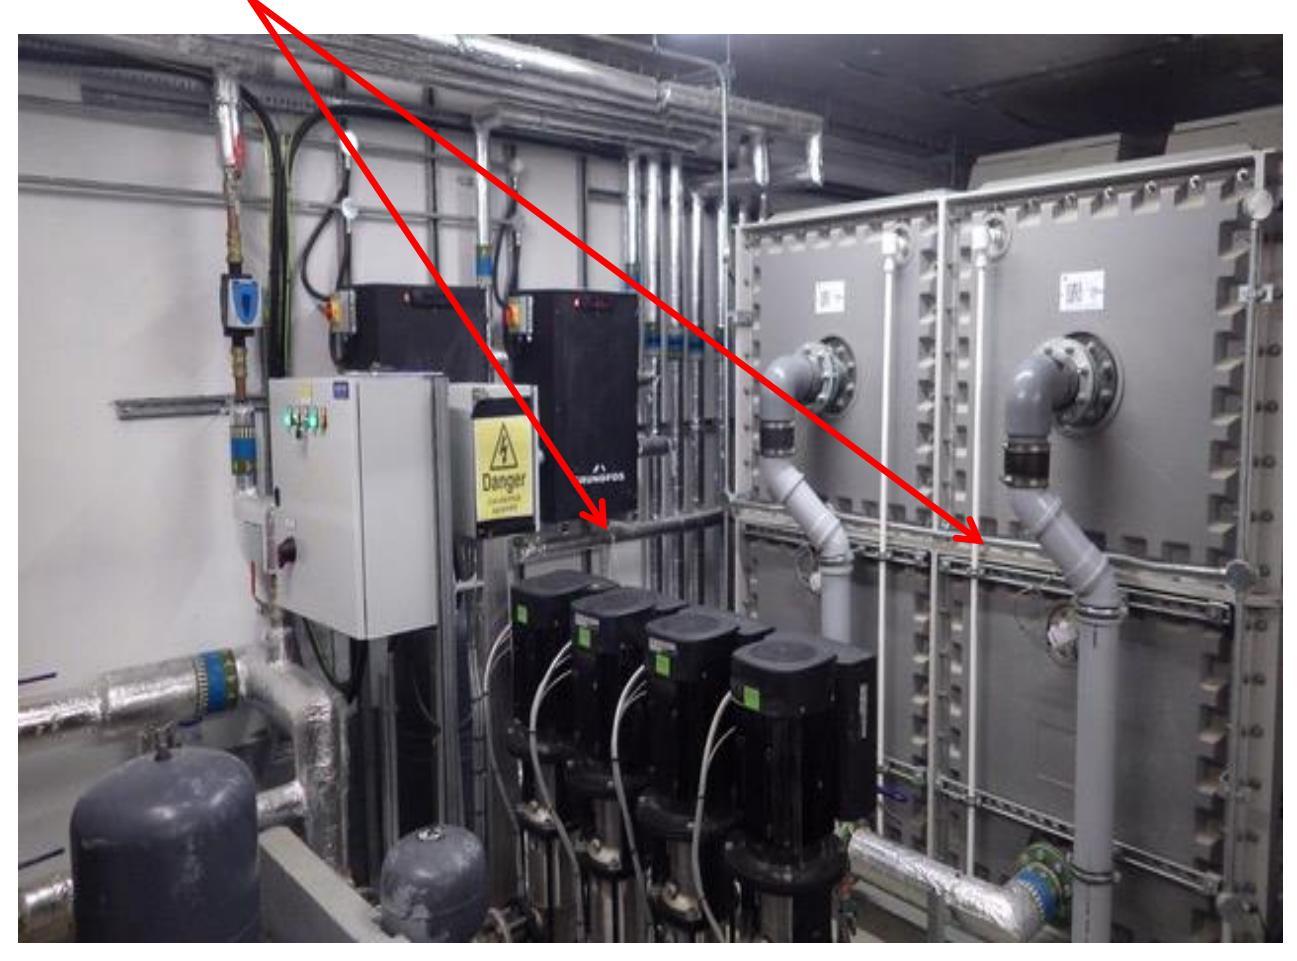
Capacity tank and pumps location, first floor plant room

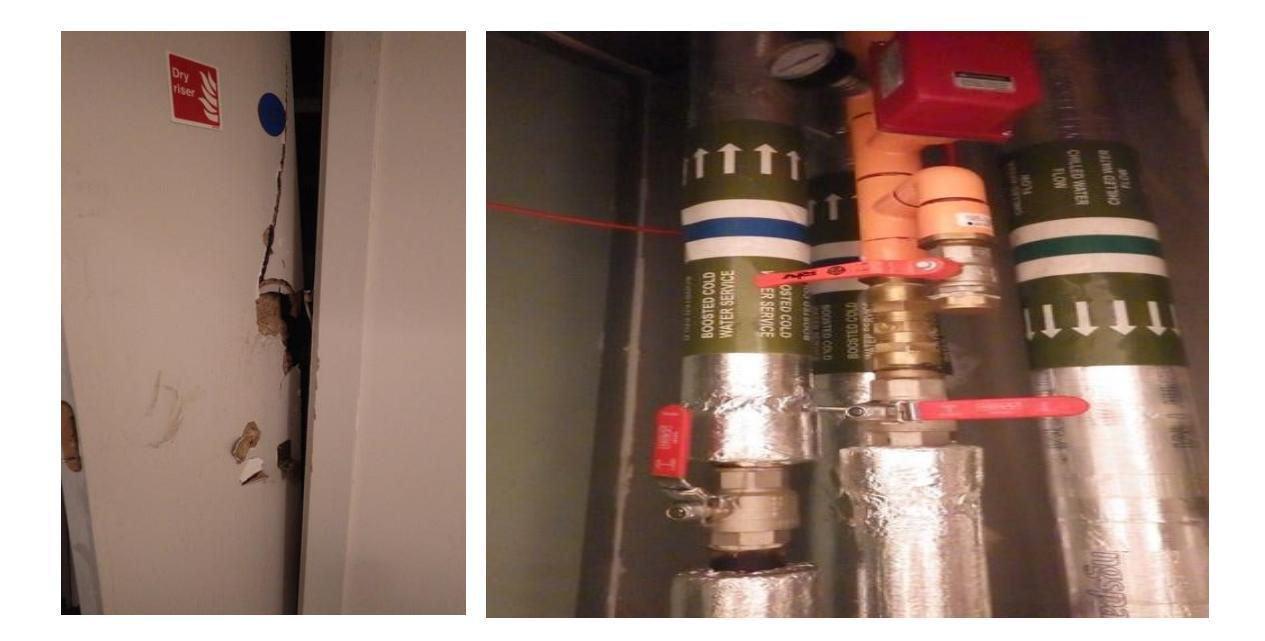
- 12.3 Considerable damage was sustained to a number of riser cupboard doors by crews trying to locate the landing isolation valves. Upon gaining access a number of isolation valves were visible, which one would you isolate?

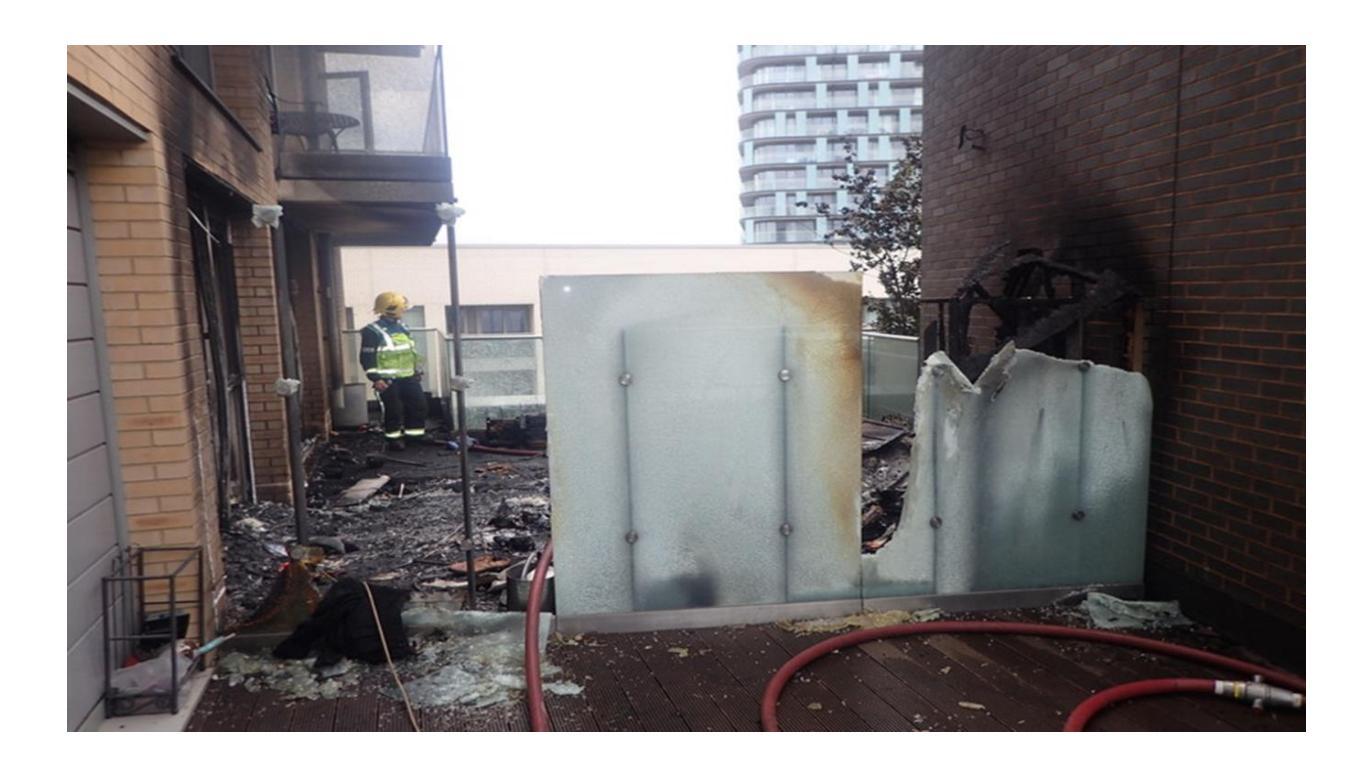
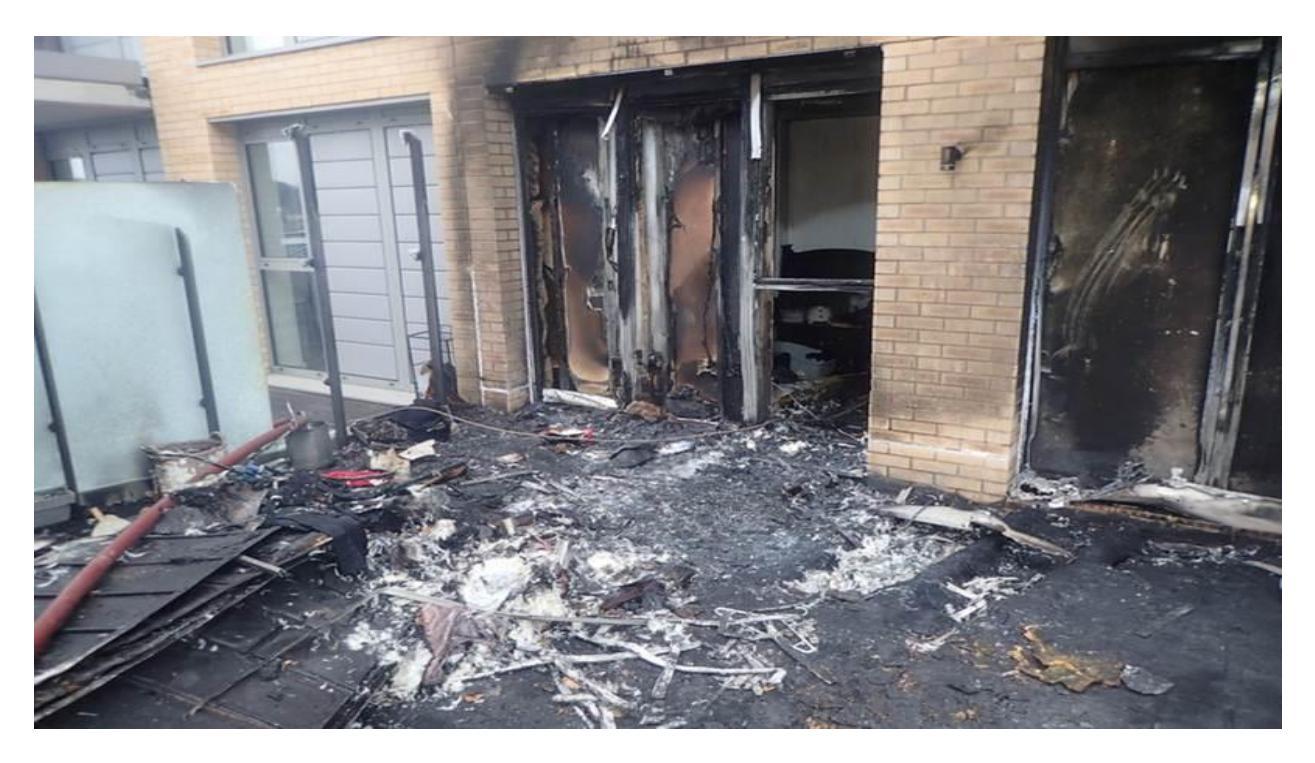
- 13.4 Previous incident, Elma Street, Lewisham.
 - Purpose built residential block of flats.
 - Date of Incident 20 June 2018.
 - Residential apartment, 6 residential nozzle heads actuated suppressing the fire from spreading into the apartment.
